MSC-00171

APOLLO 11 MISSION REPORT

MANNED SPACECRAFT CENTER  
HOUSTON, TEXAS  
NOVEMBER 1969

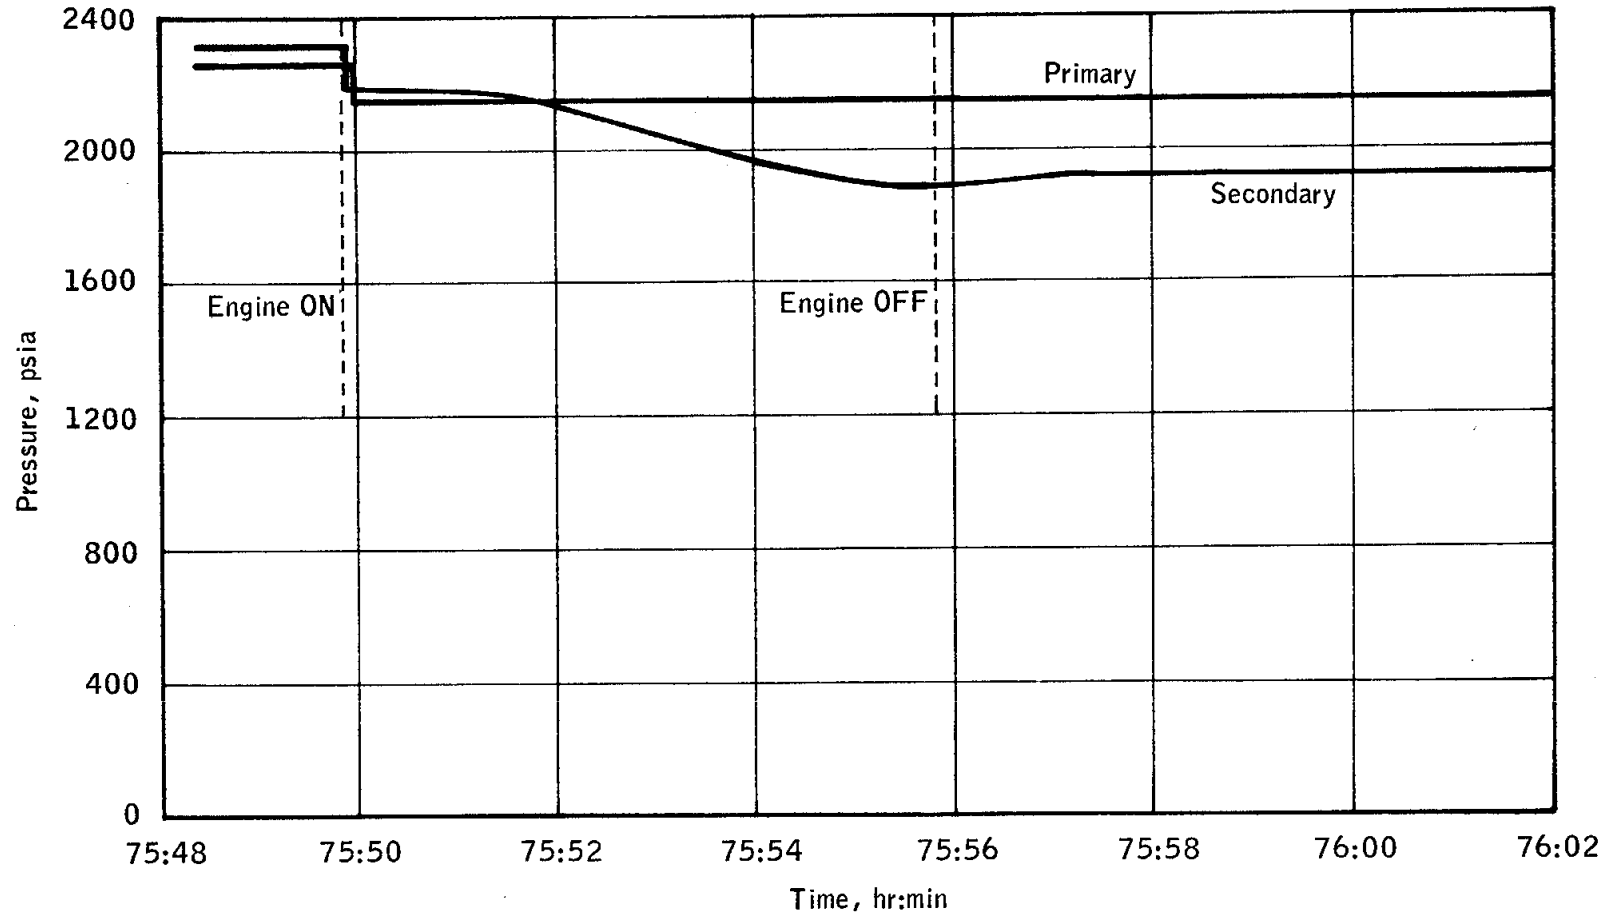
Figure 16-1.- Nitrogen pressure during initial lunar orbit insertion firing.

An abnormal decay in the secondary (system B) nitrogen pressure was observed during the lunar orbit insertion service propulsion firing, indicating a leak in the system which operates the engine upper bipropellant valve bank. No further leakage was indicated during the remainder of the mission. This anomaly is discussed in greater detail in section 16.1.1.
