**NATIONAL AERONAUTICS AND SPACE ADMINISTRATION****APOLLO 13 MISSION REPORT****DISTRIBUTION AND REFERENCING**

**MANNED SPACECRAFT CENTER****HOUSTON, TEXAS****SEPTEMBER 1970**

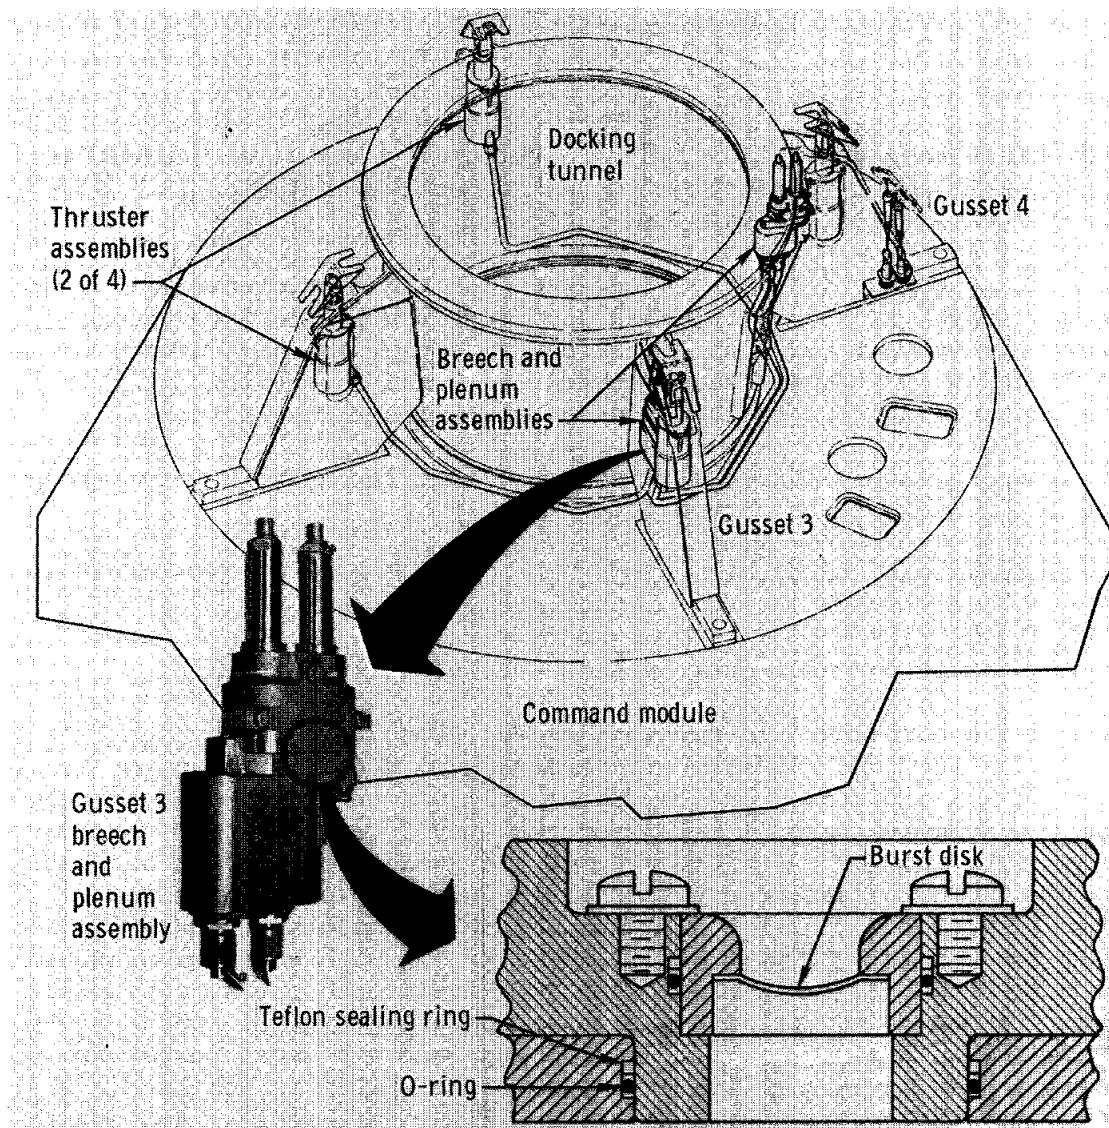
Figure 14-7.- Apex cover jettison system.

but does not specify any dimensional control over the scarf joint. Since the gap portion was burned away, a gap in the backup ring could have caused the problem.

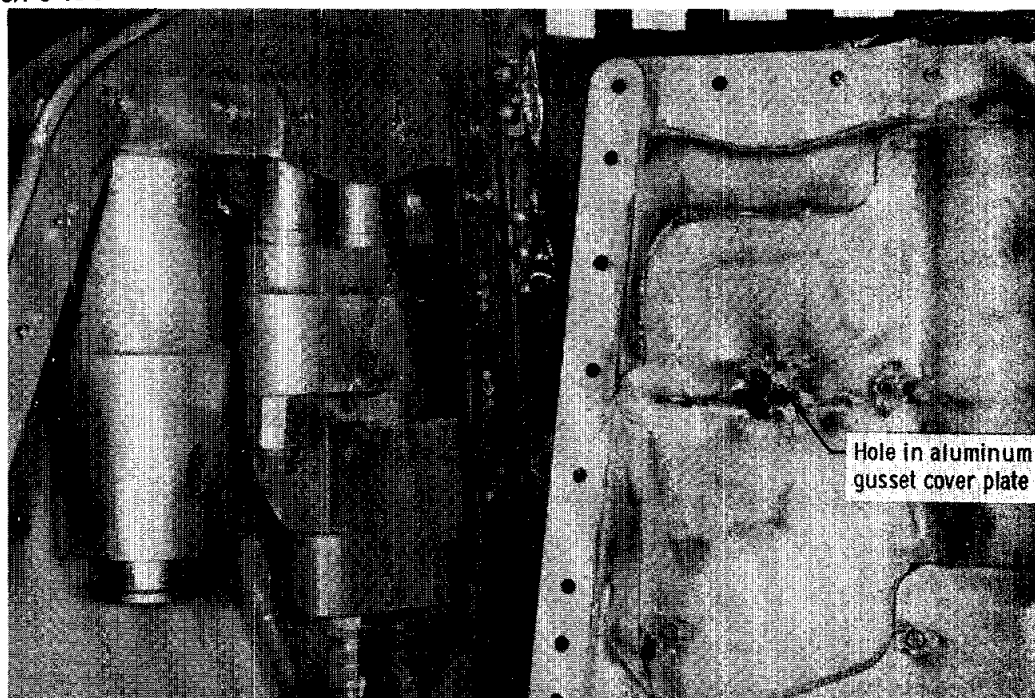
Figure 14-8.- Damage from apex jettison thruster.

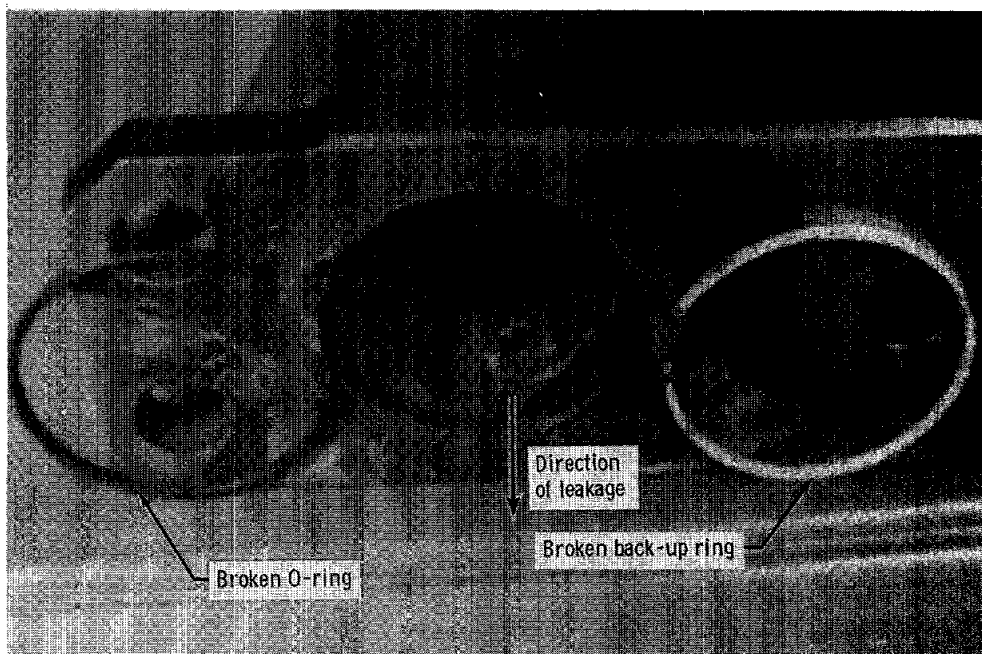
Figure 14-9.- Plenum side of breech-plenum interface.

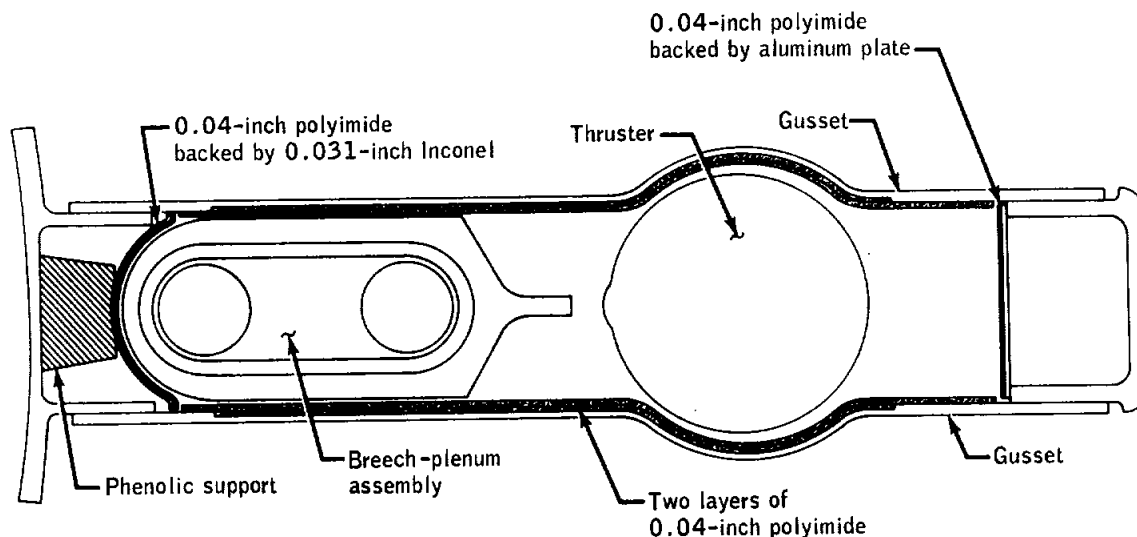
Figure 14-10.- Tunnel gusset protection.

sheet (fig. 14-10) will be applied to the interior of the breech plenum area on future spacecraft. The protection provided by the polyimide has been proof-tested by firing the assembly without the O-ring, simulating a worst-case condition.

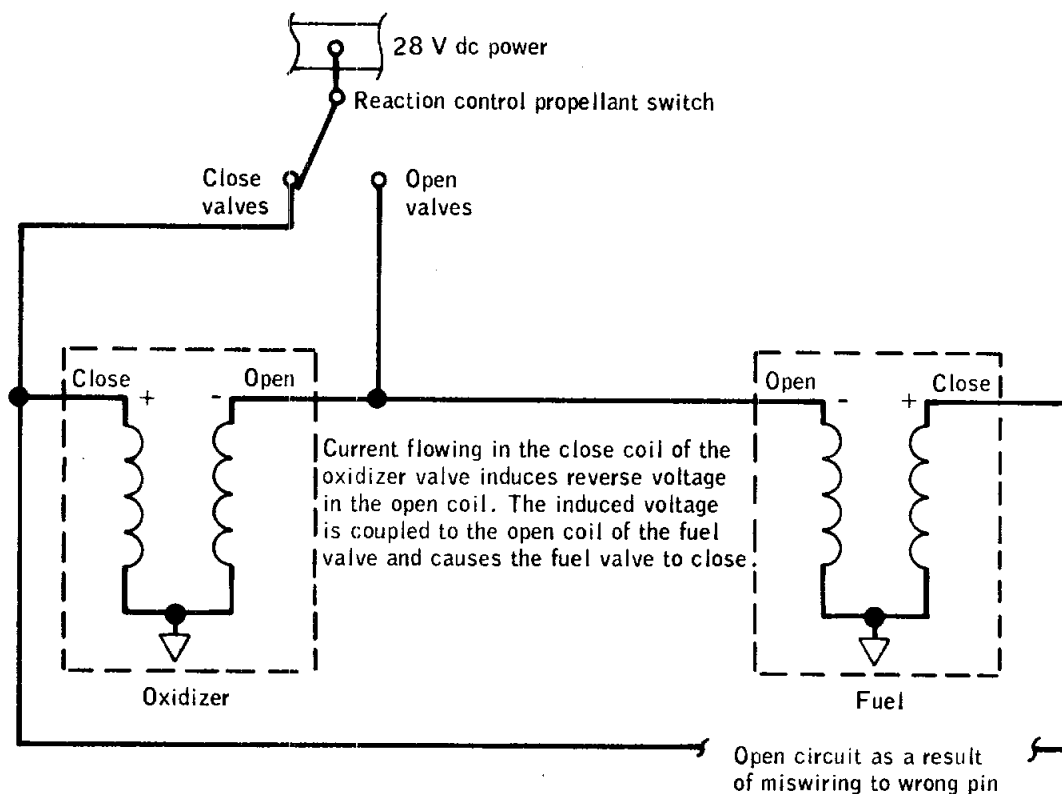
Figure 14-11.- Isolation valve circuit.

action. This voltage is applied to the fuel valve opening coil where it induces a magnetic field flux that closes the fuel valve. With 28 volts or more on the spacecraft bus, this phenomenon was consistently repeatable. With 24 to 28 volts on the bus, the valve would occasionally close, and with less than 24 volts, the valve would not close. Since preflight testing is accomplished at 28 volts, the functional tests did not disclose the miswiring. During the mission, the voltage was such that the valve did not close when commanded and therefore was found open after the flight.

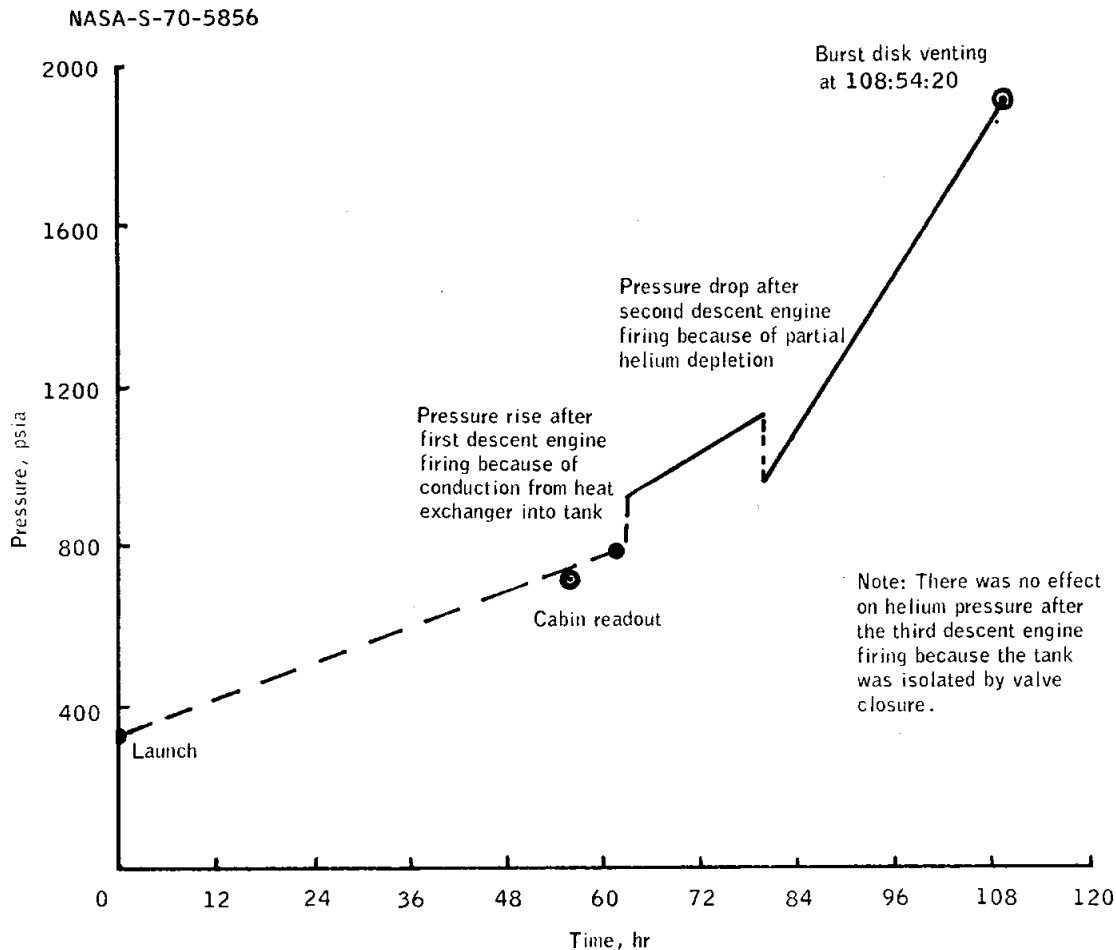
The most likely cause of the anomaly is a tank-insulation degradation which would result in increased heat conduction to the helium. The insulating characteristics of the annular vacuum in tank was most likely degraded by the introduction of a contaminant (probably hydrogen) in extremely small concentrations (approximately  $10^{-6}$  pounds). These contaminants when vaporized can exponentially increase the thermal conductivity in proportion to their vapor pressure, as indicated by special tests. While loading helium into the tank, the contaminants would freeze upon the inner shell. In the frozen state, the pressure of the contaminant is too low to significantly affect the thermal conductivity. However, the flow check which preceded the cold-soak operation would vaporize the contaminants in the vicinity of the heat exchanger lines which pass through the annulus. The subsequent increase in thermal conductivity could cause the abnormally high pressure-rise rate observed during the cold soak. These vapors would slowly condense on the cold ( $10^{\circ}$  R) inner wall, resulting in the pressure rise rate dropping to the nominal level, as was observed. The rise rate would remain normal until the helium temperature increased above the vaporization temperature of the contaminant.

Figure 14-14.- Inflight profile of supercritical helium tank pressure.

A screening test was devised for all future flight tanks to supplement normal helium tank testing. The purpose of this test is to determine the pressure rise rate for a wide range of helium temperatures from approximately 9° to 123° R. For a perfect tank, the steady-state rise rate should remain at approximately 8 psi/hour over the entire range of temperatures. The Apollo 14, 15, and 16 tanks have been subjected to the screening test, and each exhibit the same phenomena observed during Apollo 13, but to a lesser degree. For new tanks, the manufacturer will periodically analyze the gases removed from the vacuum jacket during pump down for possible contaminants. The pressure in the jacket will be measured 2 or 3 weeks after pumpdown to verify vacuum integrity.

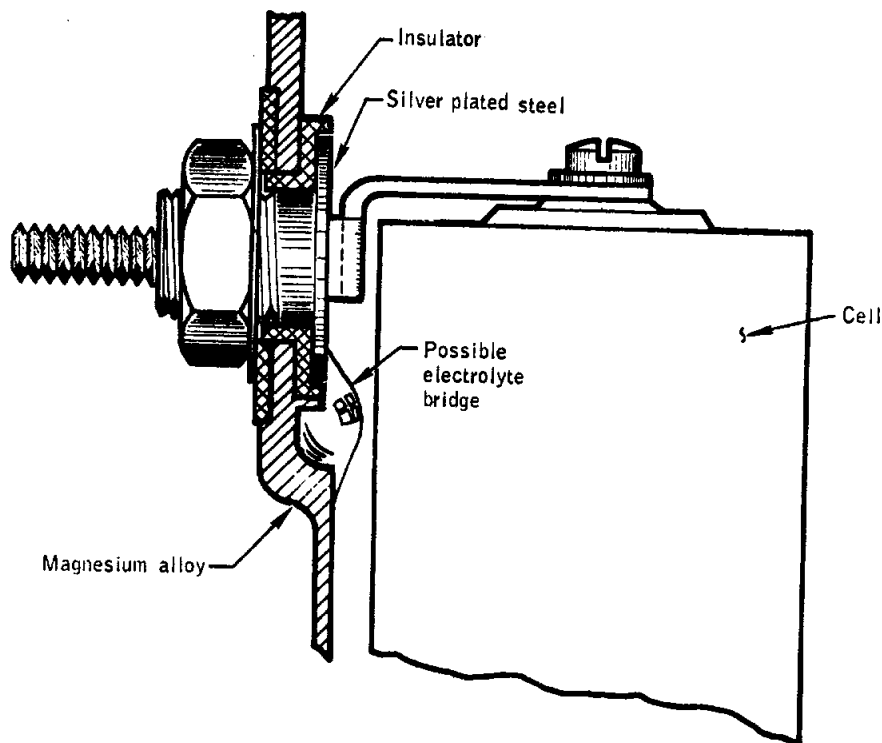
Figure 14-17.- Descent battery terminal configuration.

The battery potting will be improved to prevent electrolyte bridging between the battery terminals and case. These improvements include coating the inside of the battery case with epoxy paint before the battery is assembled and changing the potting material used at the ends of the case to a material which has better adhesion characteristics. Also, the cell chimneys will be manifolded together and to the case vent-valve with plastic tubing.

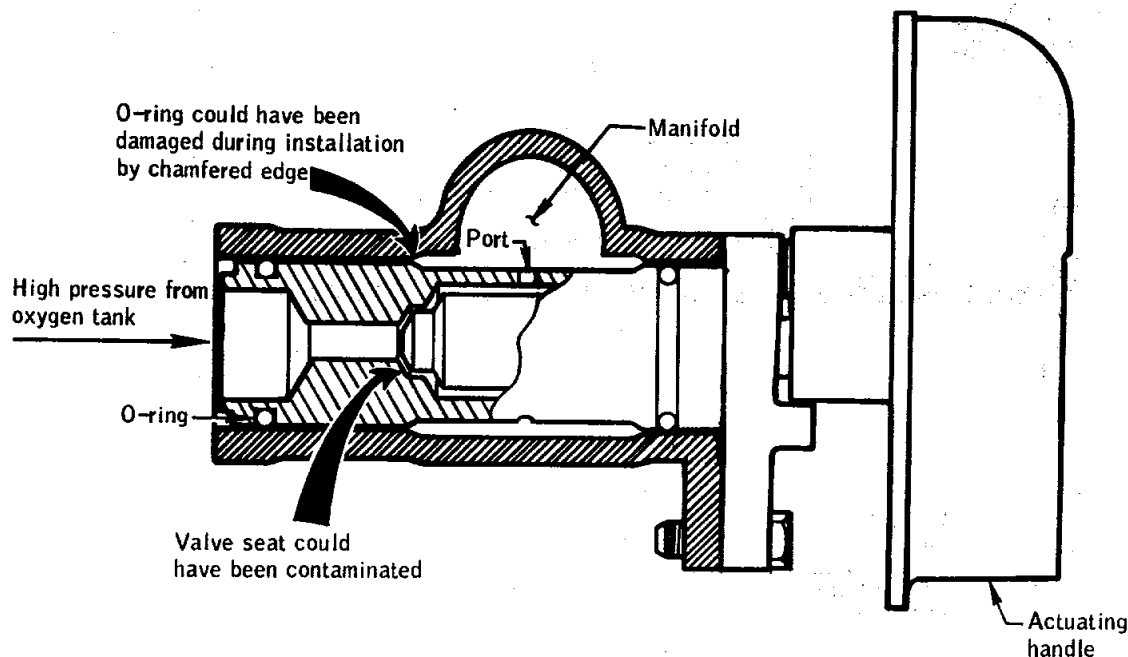
Figure 14-20.- Ascent stage tank shutoff valve.

compression allowed in the valve design would aggravate the tendency for the O-ring to roll during valve assembly.
