APOLLO 8 MISSION REPORT

MANNED SPACECRAFT CENTER  
HOUSTON, TEXAS  
FEBRUARY 1969

Mission Evaluation Team

George M. Low  
Manager, Apollo Spacecraft Program

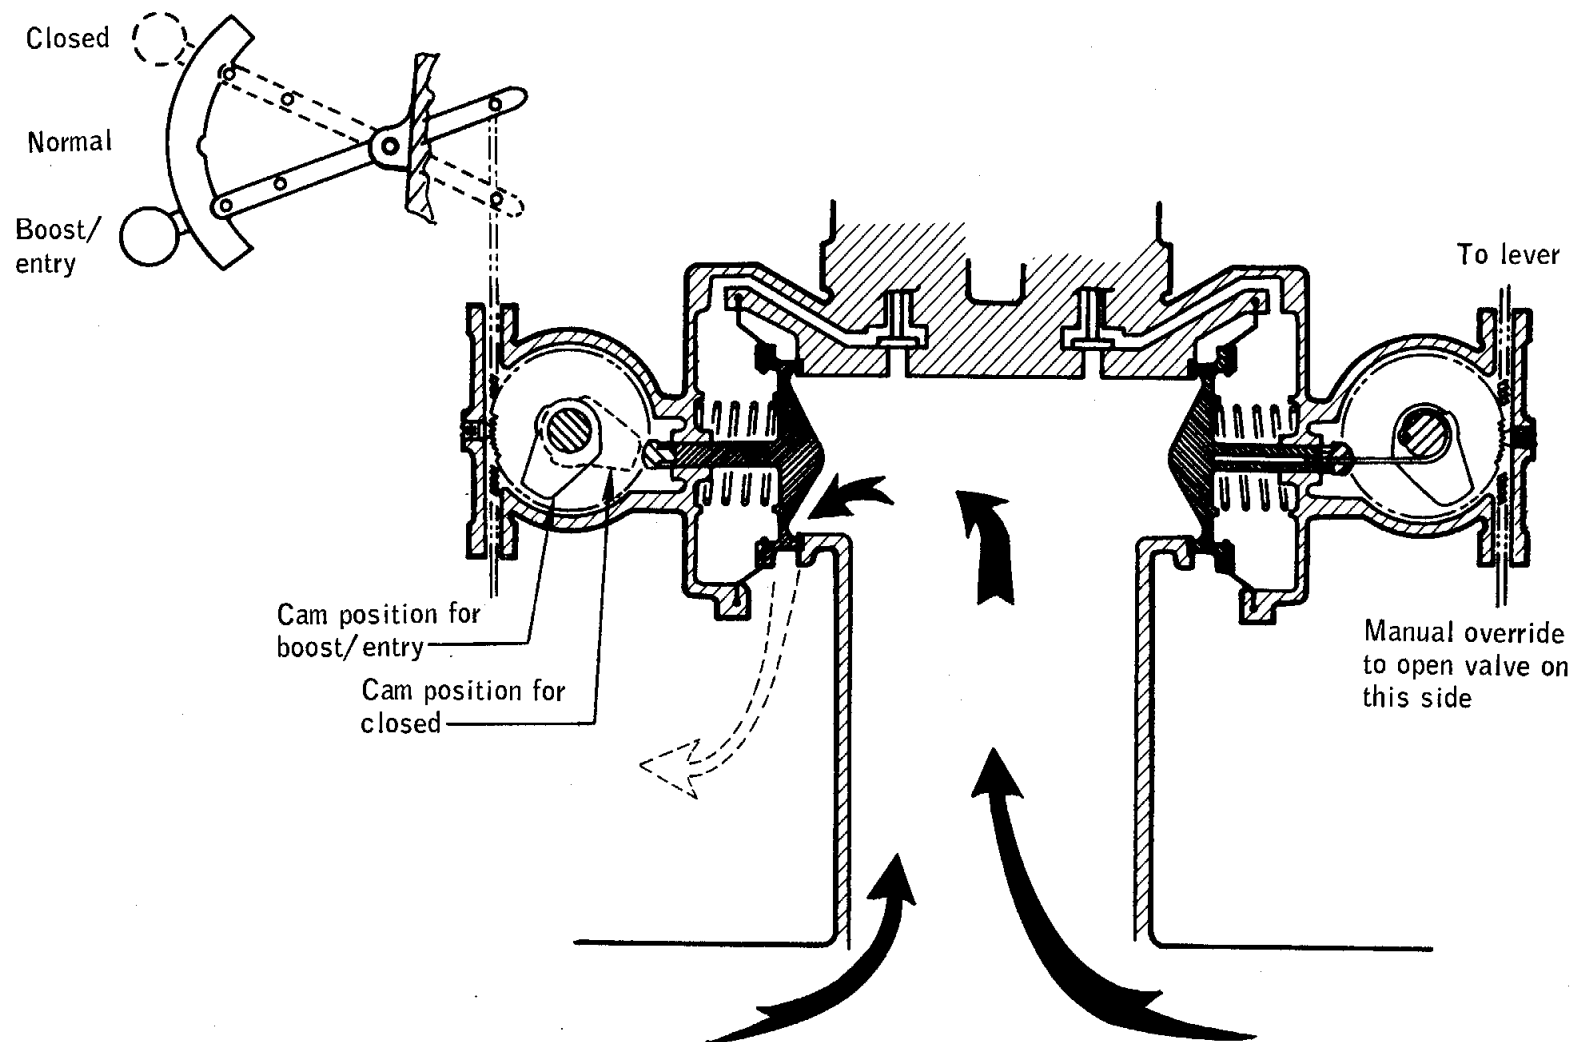
Figure 12-4.- Cabin pressure relief valve.

The crew estimated 2 to 3 quarts of water entered the cabin through the cabin pressure relief valve at landing. Postflight tests were conducted on the valve installed in the spacecraft. Test results indicate that, with both sides of the valve in the closed position, gaseous leakage through the system is 60 scc/min at a differential pressure of 18 inches of water. The differential pressure was increased up to 13 psi, with no significant increase in leakage. Test results indicate that the valve operated as designed and would not have allowed water ingestion if properly closed.
