MSC-00171

APOLLO 11 MISSION REPORT

MANNED SPACECRAFT CENTER  
HOUSTON, TEXAS  
NOVEMBER 1969

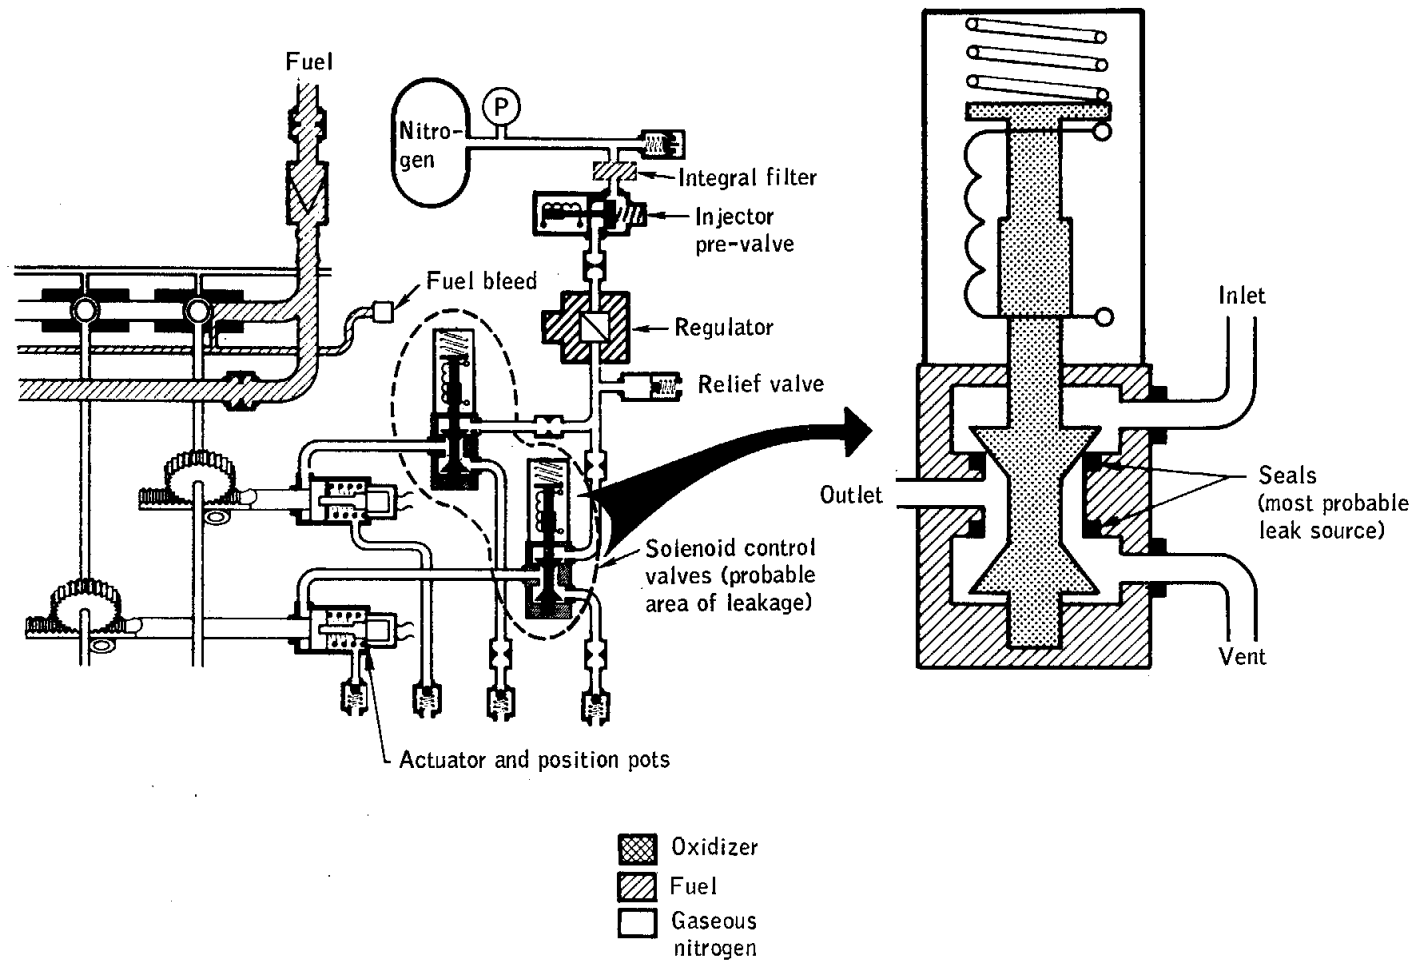
Figure 16-2.- Control for service propulsion propellants.

The fuel and oxidizer valves are controlled by actuators driven by nitrogen pressure. Figure 16-2 is representative of both nitrogen control systems. When power is applied to the service propulsion system in preparation for a maneuver, the injector pre-valve is opened; however, pressure is not applied to the actuators because the solenoid control valves are closed. When the engine is commanded on, the solenoid control valves are opened, pressure is applied to the actuator, and the rack on the actuator shaft drives a pinion gear to open the fuel and oxidizer valves. When the engine is commanded off, the solenoid control valve vents the actuator and closes the fuel and oxidizer valves.

It is concluded that the leakage was due to a contamination-induced failure of a solenoid control valve. The source of contamination is unknown; however, it was apparently removed from the sealing surface during the valve closure for the first lunar orbit insertion maneuver (fig. 16-2). A highly suspect source is a contaminated facility manifold at the vendor's plant. Although an investigation of the prior failure indicated the flight valve was not contaminated, the facility manifold is still considered a possible source of the contaminants.

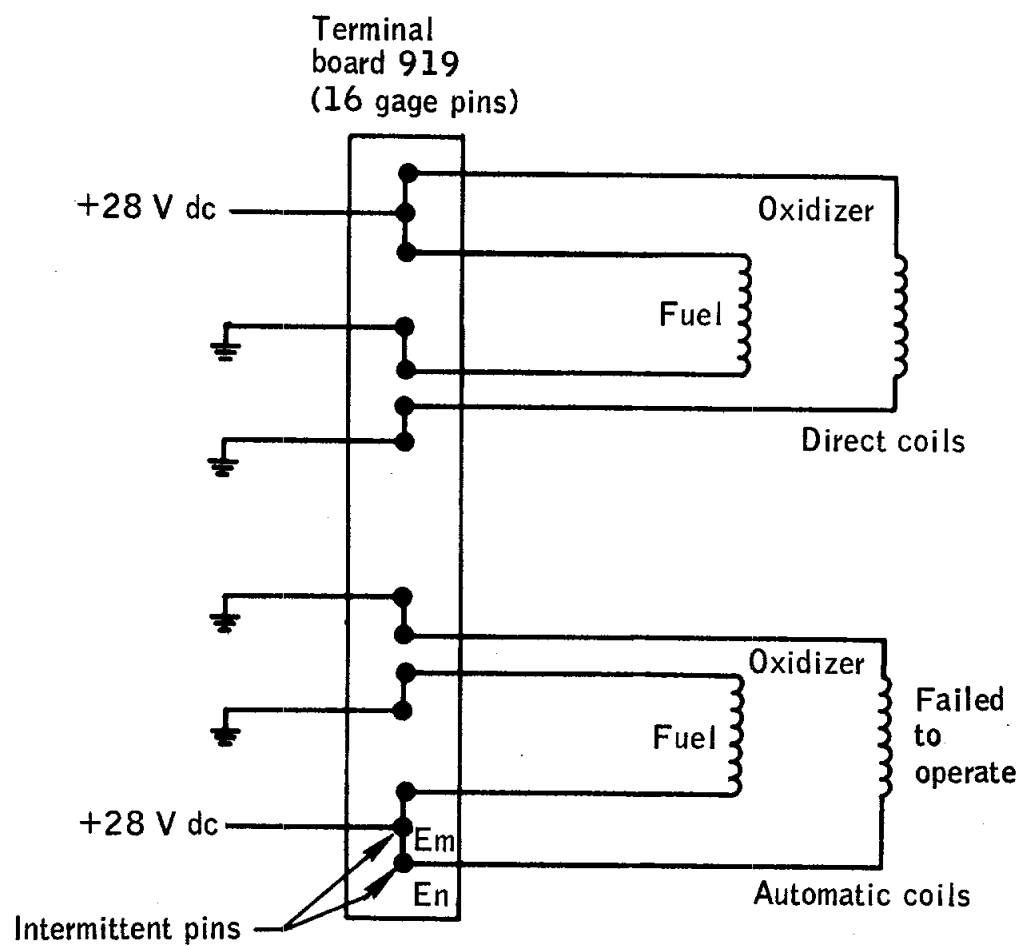
Figure 16-3.- Terminal board schematic for minus-yaw engine, command module reaction control system 1.

Postflight tests showed that two pins in the terminal board (fig. 16-3) were loose and caused intermittent continuity to the automatic coils of the engine valve. This type failure has previously been noted on terminal boards manufactured prior to November 1967. This board was manufactured in 1966.

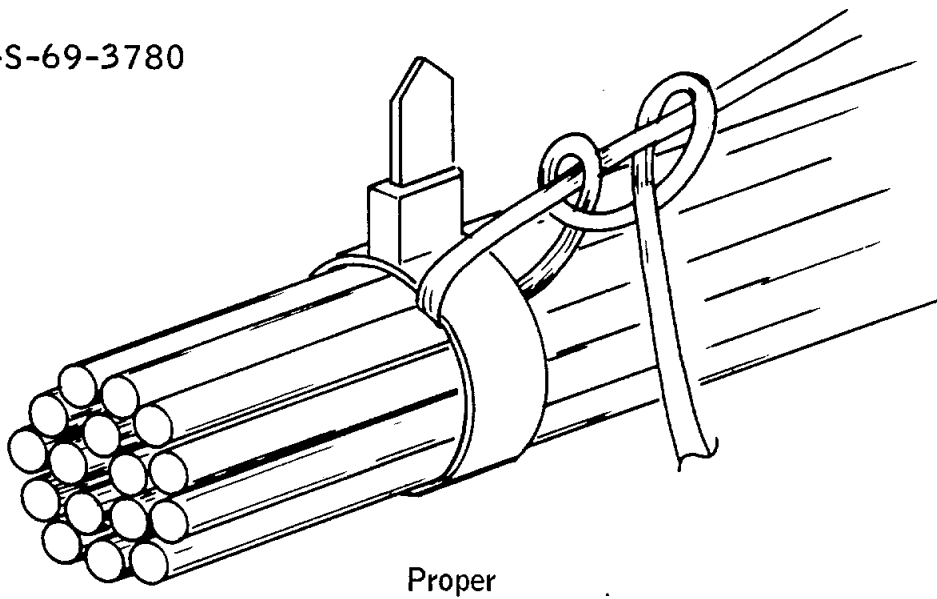
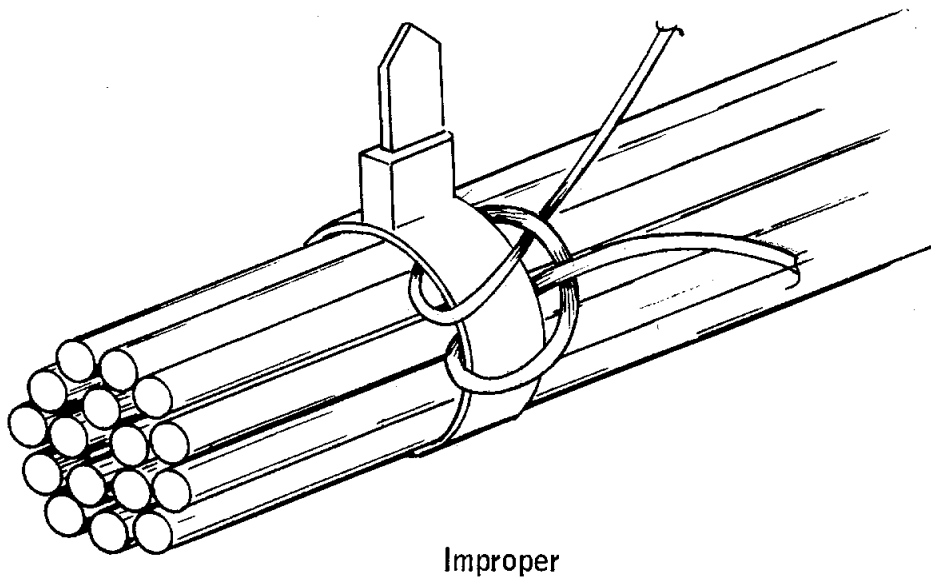
Figure 16-6.- Tie-wraps on lanyards.

The knots should be two closely tied half-hitches which secure the tie-wrap to the lanyard (fig. 16-6). Examination of the Apollo 10 lanyard indicates that these knots were not two half-hitches but a clove hitch (see figure). After the lanyard breaks the tie-wraps, if the fragment of tie wrap pulls out of the knot, the clove hitch knot can untie, thus lengthening the lanyard. Lengthening this lanyard as the umbilical cable pays out can allow transfer of some loading into the umbilical disconnects. Should a sufficient load be transferred to the disconnect fitting to cause shear pins to fail, a disconnect of the forward heat shield mortar umbilical could result prior to the mortar firing. This would prevent deployment of the forward heat shield separation augmentation parachute, and there would be a possibility of forward heat shield recontact with the command module. Examination of the forward heat shield recovered from Apollo 10 confirmed that the mortar had fired and the parachute was properly deployed.

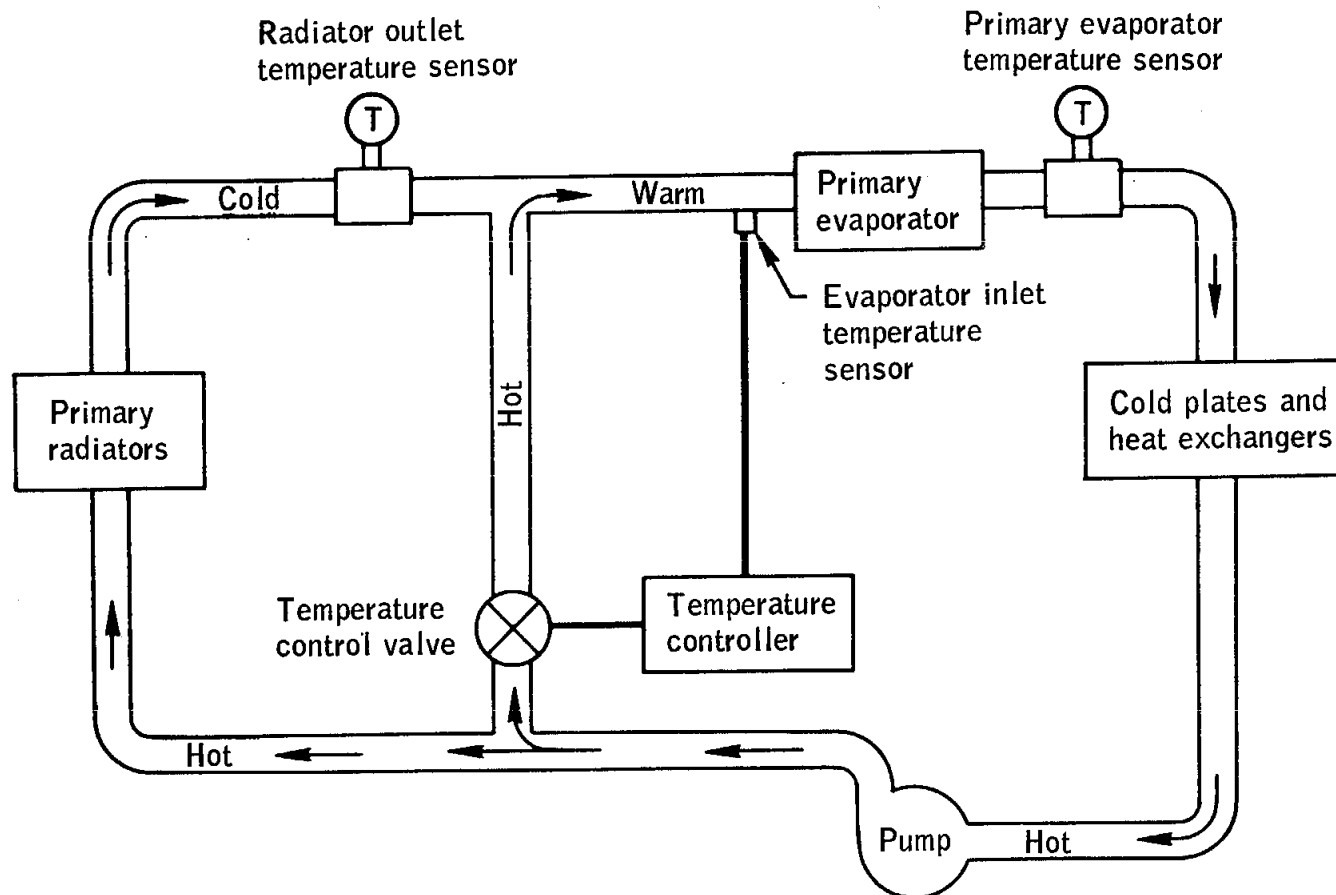
Figure 16-7.- Primary water glycol coolant loop.

An apparent anomaly exists with the glycol temperature control valve or the related temperature control system. Temperature of the water/glycol entering the evaporator is normally maintained above 42° F by the glycol temperature control valve, which mixes hot water/glycol with water/glycol returning from the radiators (see fig. 16-7). As the radiator outlet temperature decreases, the temperature control valve opens to allow

Two problems occurred on Apollo 11, primarily during lunar orbit operations. First, as the temperature of the water/glycol returning from the radiators increased, the temperature control valve did not close fast enough, thus producing an early rise in evaporator outlet temperature. Second, the evaporator outlet temperature decreased to  $31^{\circ}$  F during revolution 15 as the radiator outlet temperature was rapidly decreasing (see fig. 16-8). The figure also shows normal operation of the valve and control system after the problem. Both anomalies disappeared about the time the glycol evaporator temperature inlet switch was cycled by the crew during revolution 15. The temperature control valve and related control system continued to operate satisfactorily for the remainder of the mission.

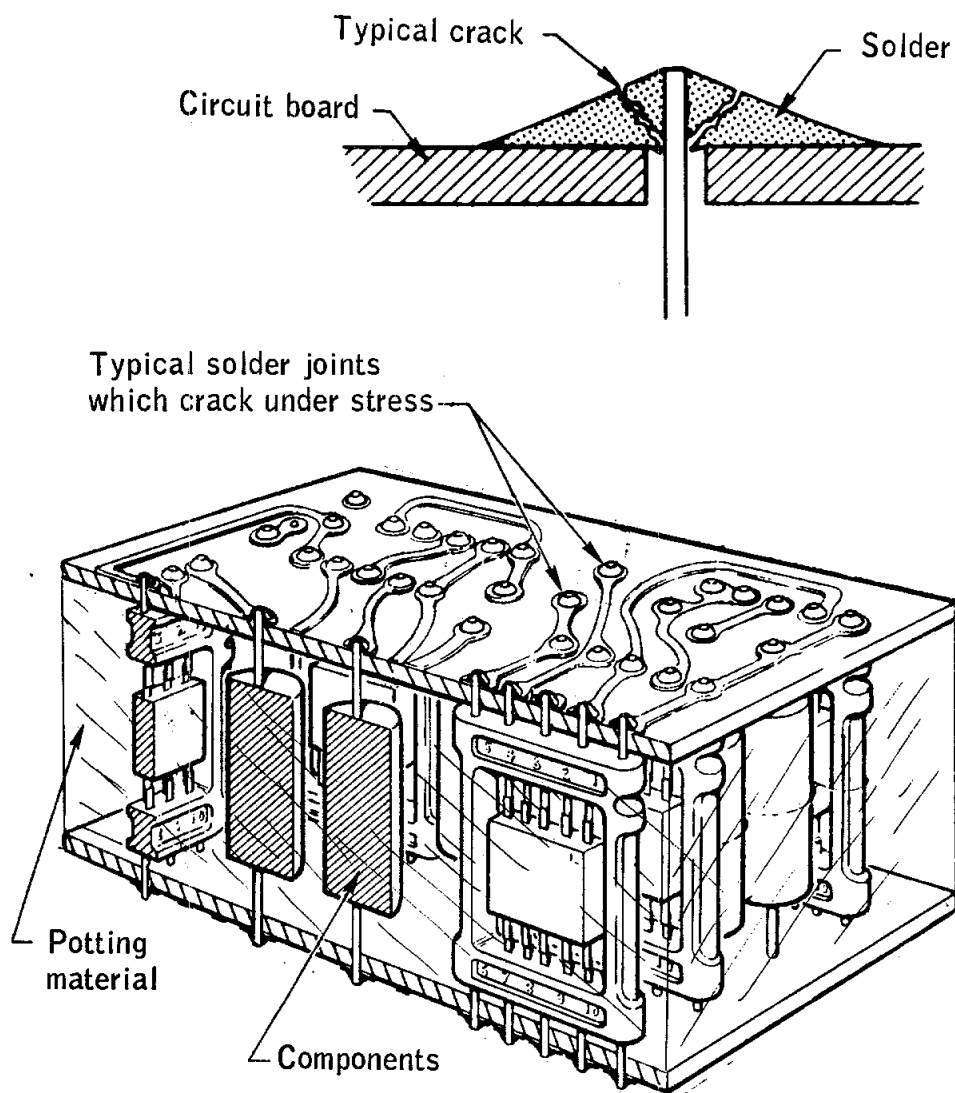
Figure 16-9.- Typical modular construction.

Based on the characteristic behavior of this timer and the similarity to previous timer failures, the most probable cause of failure is a cracked solder joint. A cracked solder joint is the result of cordwood construction, where electrical components (resistors, capacitors, diodes, etc.) are soldered between two circuit boards, and the void between the boards is filled with potting compound (fig. 16-9). The differential expansion between the potting compound and the component leads causes the solder joints to crack, breaking electrical contact. Presumably, the 11-hour period the timer was off allowed it to cool sufficiently for the cracked joint to make electrical contact, and then the timer operated normally.

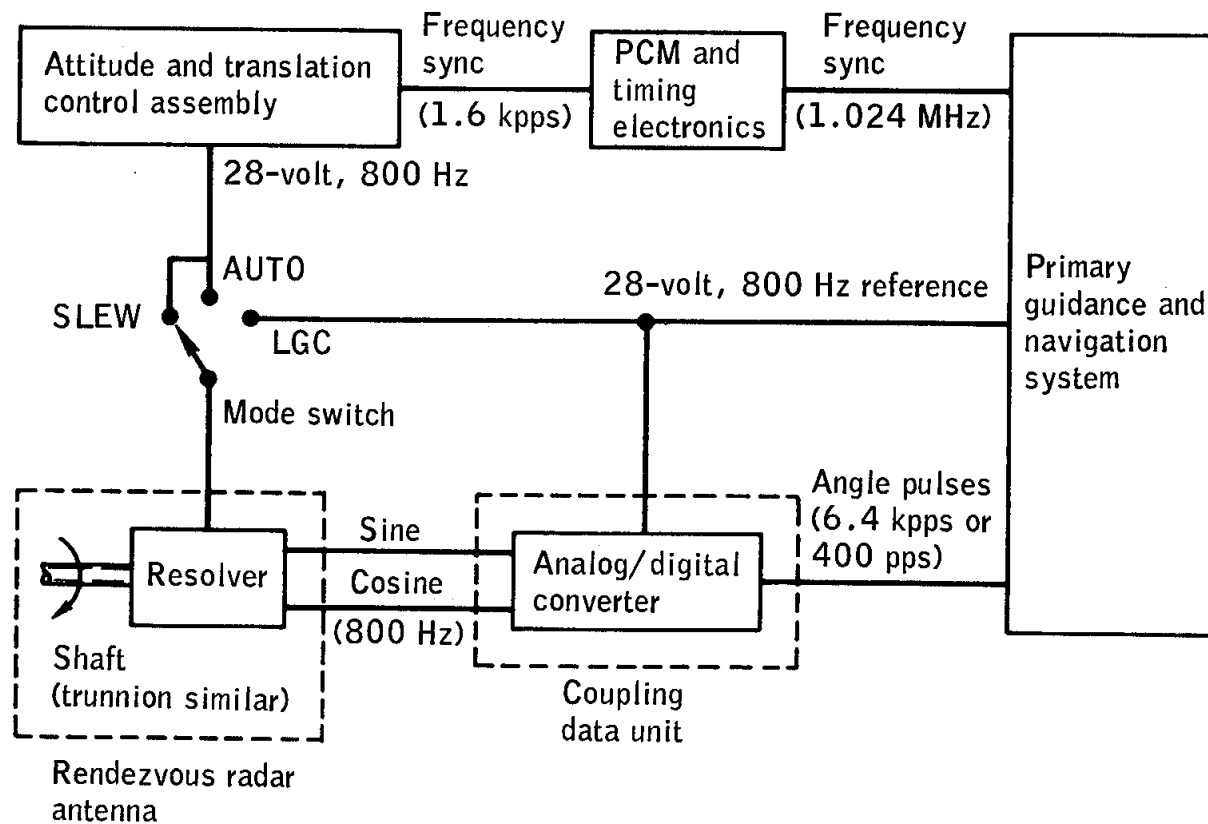
Figure 16-14.- Interfaces from rendezvous radar antenna to primary guidance system.

The alarms were of the Executive overflow type, which signify that the guidance computer cannot accomplish all of the data processing requested in a computation cycle. The alarms indicated that more than 10 percent of the computational capacity of the computer was preempted by unexpected counter interrupts of the type generated by the coupling data units that interface with the rendezvous radar shaft and trunnion resolvers (see fig. 16-14).

The interrupts during the powered descent resulted from the configuration of the rendezvous radar/coupling data unit/computer interface. A schematic of the interface is shown in figure 16-14. When the rendezvous radar mode switch is in the AUTO or SLEW position, the excitation for the radar shaft and trunnion resolvers is supplied by a 28-volt, 800-hertz signal from the attitude and translation control assembly. When the switch is in the LGC position, the positioning of the radar antenna is controlled by the guidance computer, and the resolver excitation is supplied by a 28-volt, 800-hertz source in the primary guidance and navigation system. The output signals of the shaft and trunnion resolvers interface with the coupling data units regardless of the excitation source. The attitude and translation control assembly voltage is locked in frequency with the primary guidance and navigation system voltage through the system's control of the PCM and timing electronics frequency, but it is not locked in phase. When the mode switch is not in LGC, the attitude and translation control assembly voltage is the source for the resolver output signals to the coupling data units while the primary guidance and navigation system 800-hertz voltage is used as a reference voltage in the analog-to-digital conversion portion of the coupling data unit. Any difference in phase or amplitude between the two 800-hertz voltages will cause the coupling data unit to recognize a change in shaft or trunnion position, and the coupling data unit will "slew" (digitally). The "slewing" of the data unit results in the undesirable and continuous transmission of pulses representing incremental angular changes to the computer. The maximum rate for the pulses is 6.4 kpps, and they are processed as counter interrupts. Each pulse received by the computer requires one memory cycle time (11.7 microseconds) to process. If a maximum of 12.8 kpps are received (two radar coupling data units), 15 percent of the available computer time will be spent in processing the radar interrupts. (The computer normally operates at approximately 90 percent of capacity during peak activity of powered descent.) When the capacity of the computer is exceeded, some repetitively scheduled routines will not be completed prior to the start of the next computation cycle. The computer then generates a software restart and displays an Executive overflow alarm.

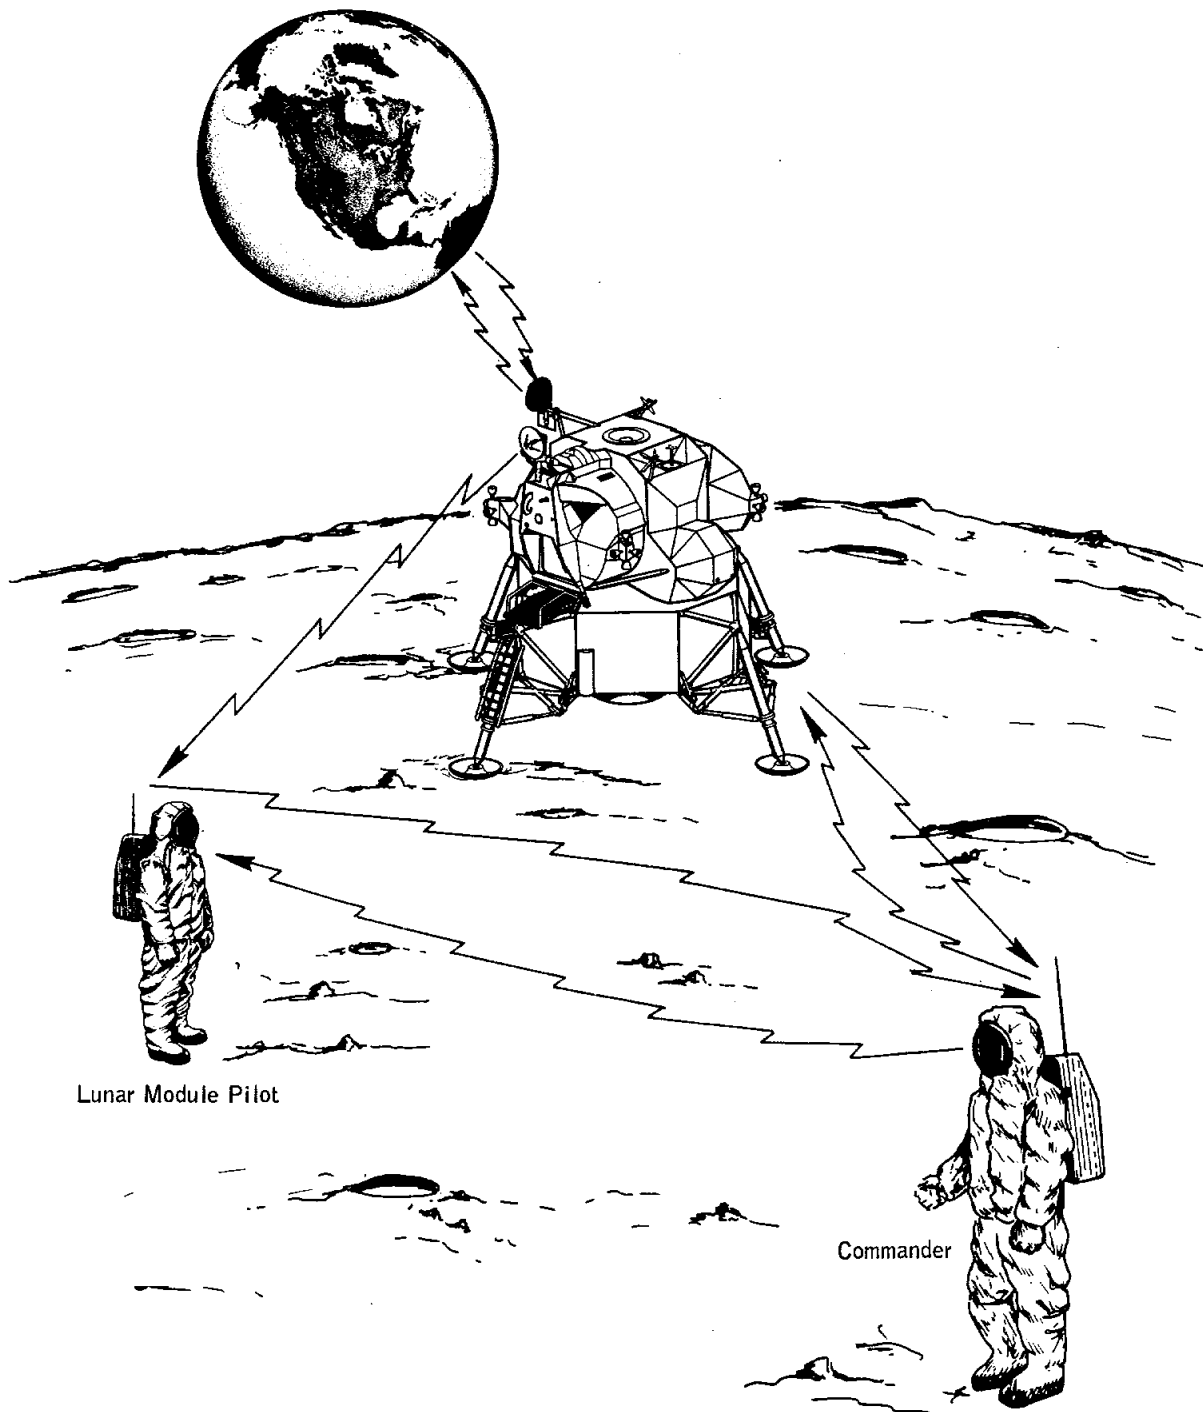
Figure 16-16.- Communications relays during extravehicular activity.

A voice turnaround (echo) was heard during extravehicular activity. At that time, the lunar module was operating in a relay mode. Uplink voice from the S-band was processed and retransmitted to the two extravehicular crewmen via the lunar module VHF transmitter. Crew voice and data were received by the lunar module VHF receiver and relayed to the earth via the lunar module S-band transmitter (see fig. 16-16). The echo was duplicated in the laboratory and resulted from mechanical acoustical coupling between the communications carrier earphone and microphone (fig. 16-17). The crew indicated that their volume controls were set at maximum during the extravehicular activity. This setting would provide a level of approximately plus 16 dBm into each crewman's earphones. Isolation between earphones and microphones, exclusive of air path coupling, is approximately 48 dB. The ground voice signal would therefore appear, at the microphone output, at a level of approximately minus 32 dBm. Assuming extravehicular communication keying is enabled, this signal would be processed and transmitted by the extravehicular communications system and would provide a level of approximately minus 12 dBm at the output of the lunar module VHF receiver. If the lunar module relay is enabled, this signal would be amplified and relayed to earth via S-band at a nominal output level.

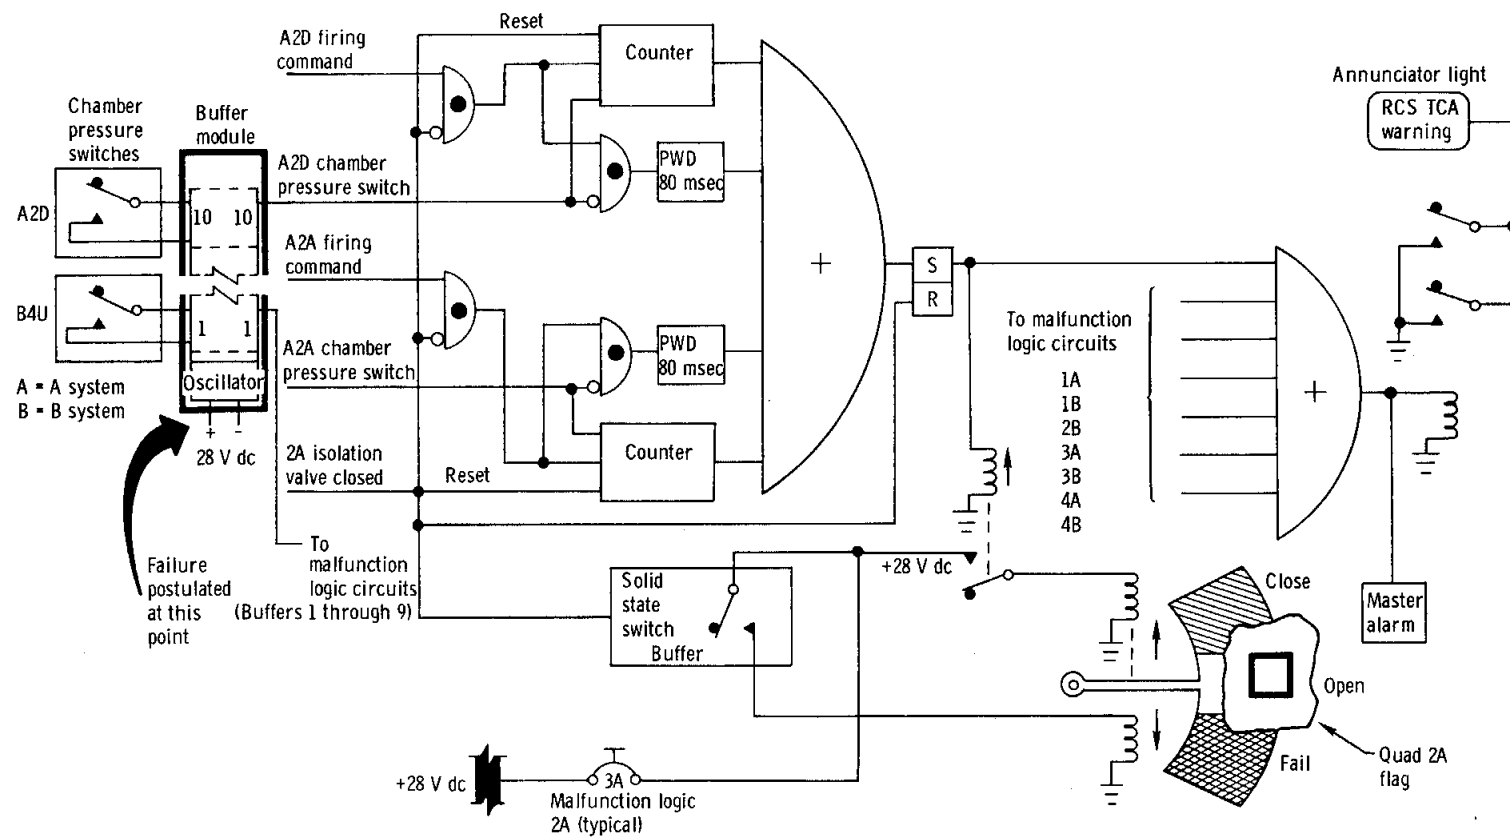
Figure 16-20. - Reaction control system malfunction detection circuits (caution and warning system).

The first two possible causes are highly unlikely because simultaneous multiple failures would have to occur and subsequently be corrected. The third possible cause is the most likely to have occurred where a single point failure exists. Ten of the sixteen engine pressure switch outputs are conditioned by the ten buffers in one module in the signal conditioner electronics assembly (fig. 16-20). This module is supplied with +28 V dc through one wire. In addition, the module contains an oscillator which provides an ac voltage to each of the ten buffers. If either the +28 V dc is interrupted or the oscillator fails, none of the ten buffers will respond to pressure switch closures. If engines monitored by these buffers are then commanded on, the corresponding warning flags will come up and a master alarm will occur.

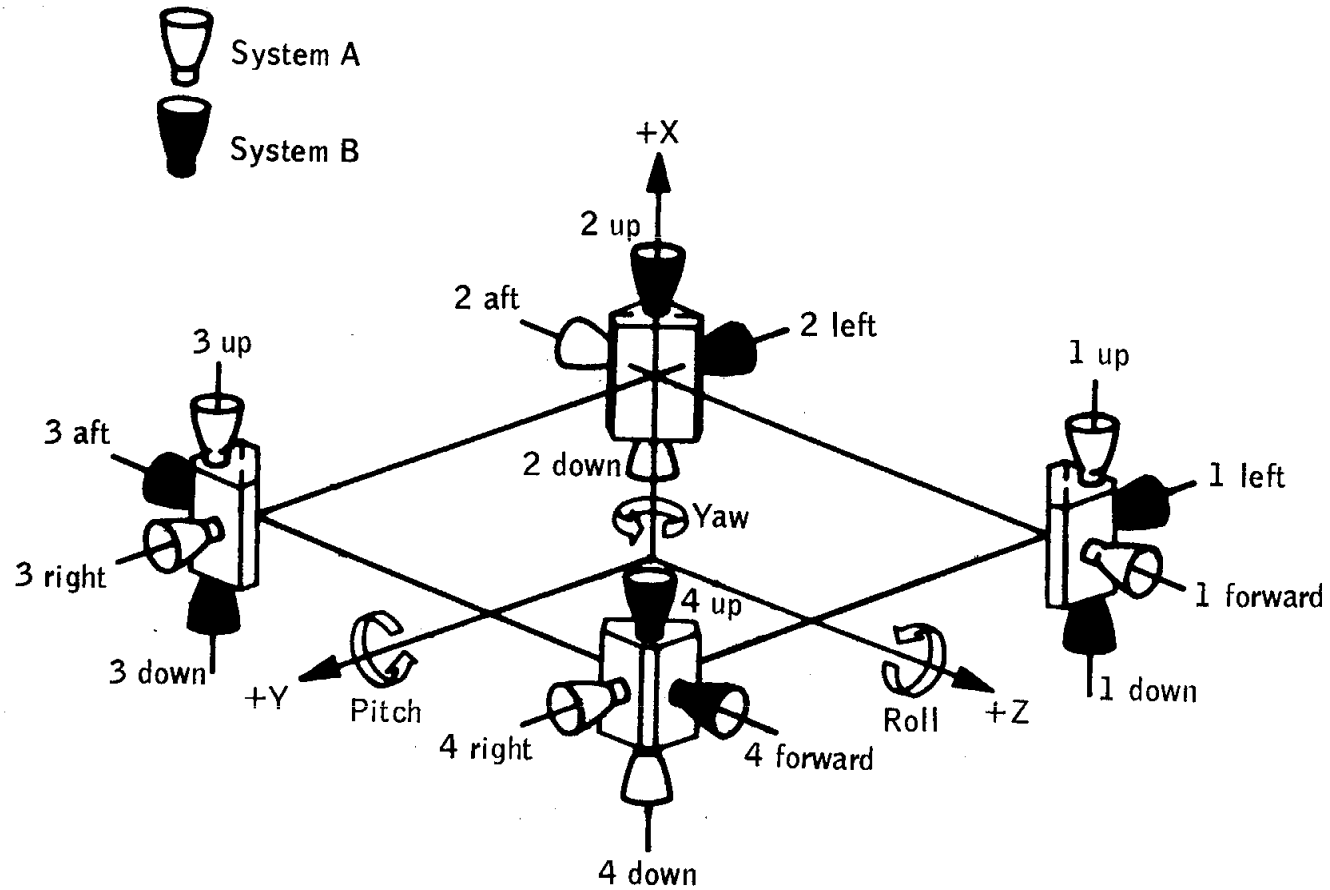
Figure 16-21.- Reaction control system geometry.

If +X translation were commanded (fig. 16-21), the down-firing engines in quads 2 and 4 of system A could fire, giving flags 2A and 4A. A subsequent minus X rotation could fire the forward-firing thruster in quad 4 of system B and the aft-firing thruster in quad 2 of system A, giving flag 4B. The aft-firing engine in quad 2 of system A (A2A) is not monitored by one of the ten buffers postulated failed. The failure then could have cleared itself. The response of the vehicle to thruster firings would have been normal under these conditions. There is no history of similar failures either at package or module level in the signal conditioner electronics assembly. No corrective action will be taken.

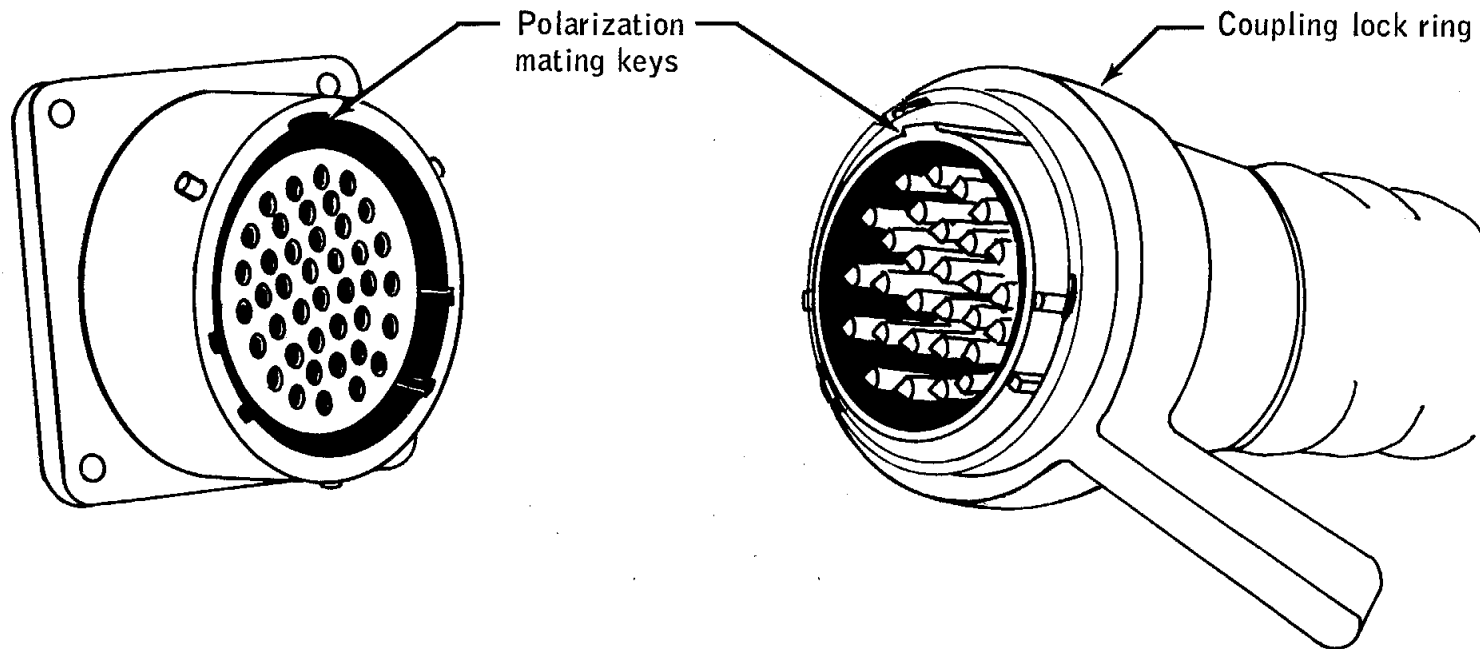
Figure 16-22.- Connector between remote control unit and portable life support system.

During preparation for extravehicular activity, the crew experienced considerable difficulty in mating the electrical connectors from the remote control unit to the portable life support system. For rotational polarization alignment, it was necessary to grasp the cable insulation because the coupling lock ring was free for unlimited rotation on the connector shell (see fig. 16-22).
