**NATIONAL AERONAUTICS AND SPACE ADMINISTRATION****APOLLO 13 MISSION REPORT****DISTRIBUTION AND REFERENCING**

**MANNED SPACECRAFT CENTER****HOUSTON, TEXAS****SEPTEMBER 1970**

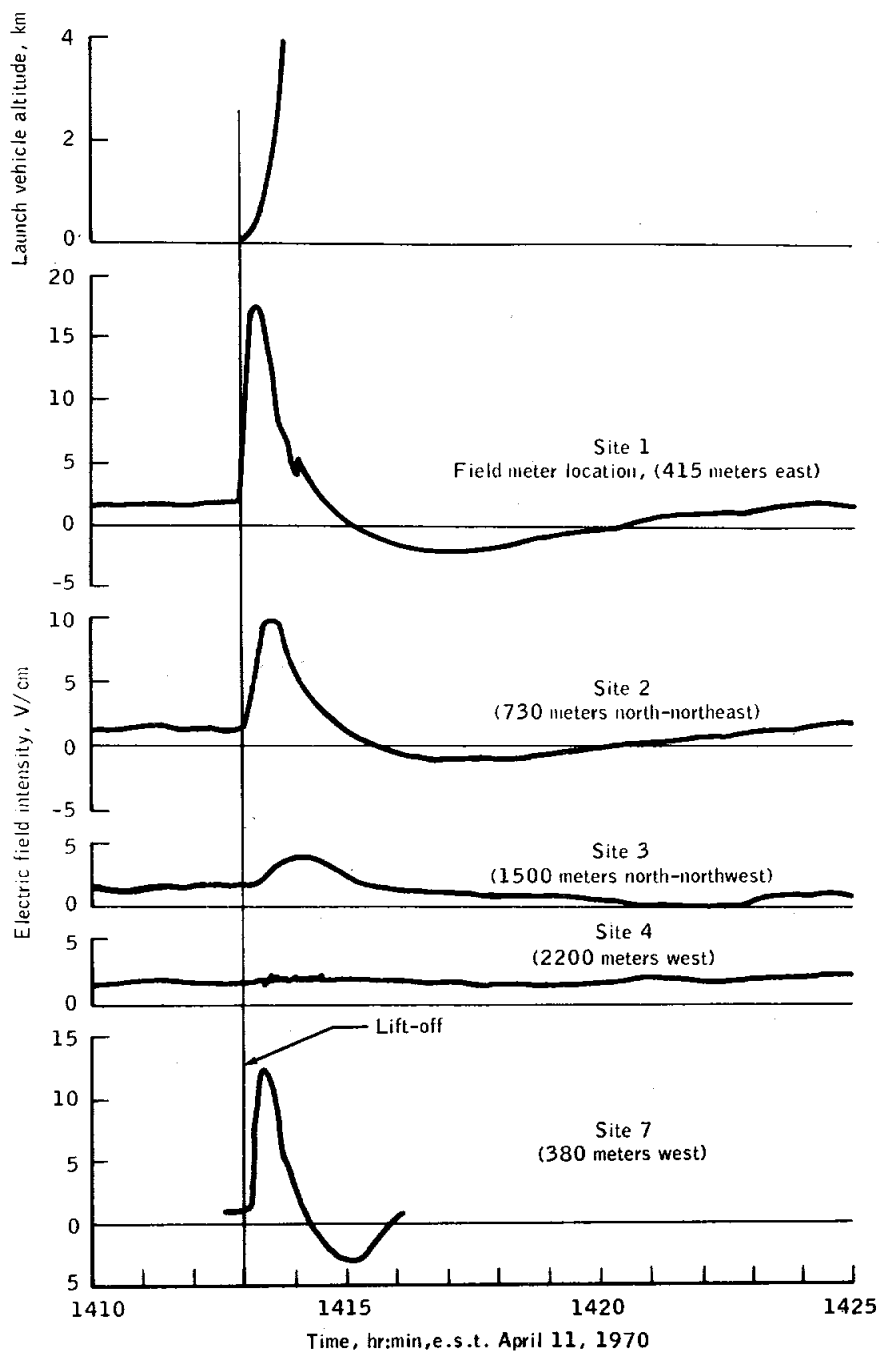
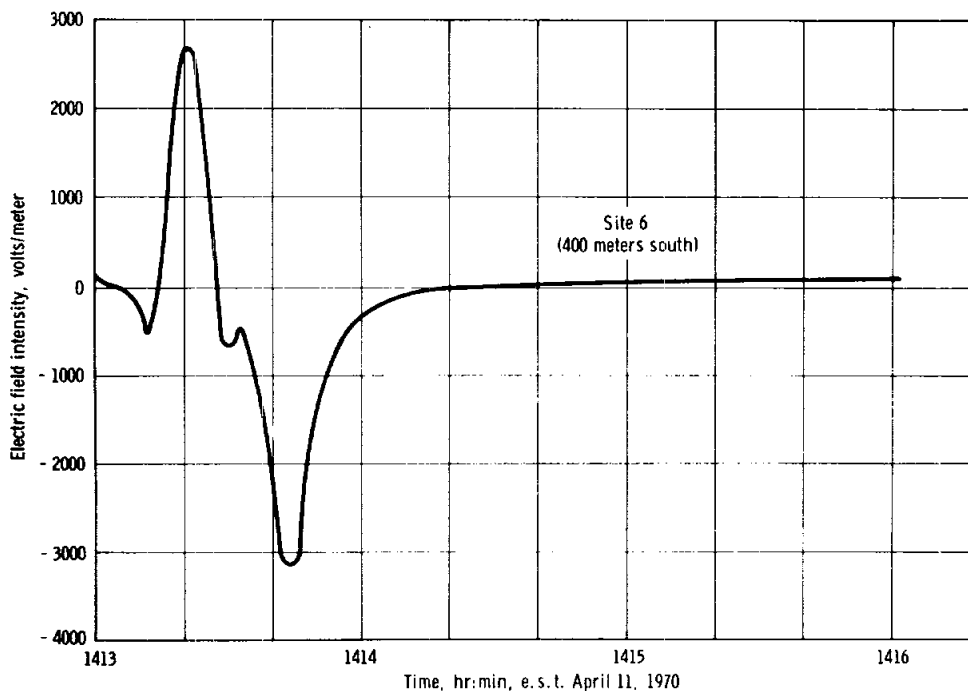
Figure 11.1-3.- Electrical discharge data for the Apollo 13 launch.

gravel and dust stirred up by the exhaust of the launch vehicle engine. After launch, a quantity of such debris was found near the surface of the field meter and its surrounding area. After the oscillations had subsided at T plus 40 seconds, there was a large negative field of approximately minus 3000 volts/meter which probably resulted from the exhaust and steam clouds that tended to remain over site 6.

The above field meter records indicate the launch of the Apollo 13 vehicle produced a significant separation of electrical charge which could possibly increase the hazard in an otherwise marginal weather situation. At the present time the location and amount of the charge on the vehicle or exhaust clouds or a combination thereof are not well understood.

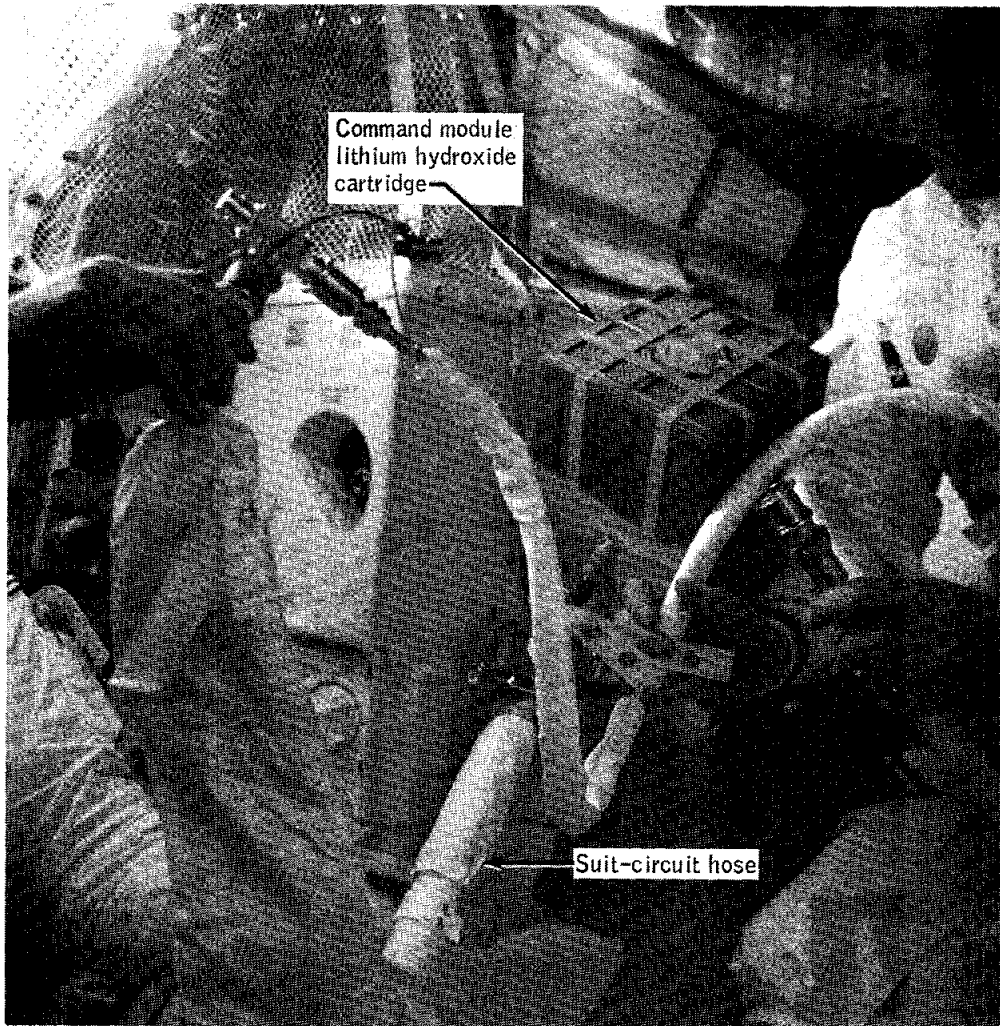
Figure 6.7-1.- Supplemental carbon dioxide removal system.

The installed primary lithium hydroxide cartridge was used for approximately 27 hours (82 man-hours) following activation of the lunar module at about 58 hours. The secondary cartridge was selected at about 85 1/2 hours. During operation of the lunar module carbon dioxide removal system, the level was permitted to increase to an indicated 14.9 mm Hg. The primary cartridge is nominally rated for a usage capacity of 41 man-hours at 520 Btu/man-hour. The secondary cartridge, nominally rated for about 17.9 man-hours, was used for 8 1/2 hours (25 1/2 man-hours). This cartridge is identical to that used in the portable life support system. A second primary cartridge was installed and used for approximately 6 minutes, but for the remainder of the mission, command module lithium hydroxide cartridges were operated in a special arrangement. One side of each of two command module cartridges was covered and sealed with a plastic bag normally used to store a liquid-cooling garment. As shown in figure 6.7-1, one corner of the bag was sealed to the inlet of the suit circuit hose. The cabin atmosphere then returned to the lunar module suit circuit through these supplemental cartridges by way of the two outlet hoses. The mass flow through this arrangement was partially restricted with tape to properly load the suit-circuit compressors. After approximately 20 hours of operation with two command module cartridges, an additional unit was stacked on each original cartridge to improve the carbon dioxide removal capability. With this supplemental configuration, when only command module cartridges were being used, the indicated carbon dioxide level was maintained between 0.1 and 1.8 mm Hg. The supplemental removal configuration using the command module lithium hydroxide cartridges was assembled and tested on the ground during the flight prior to its actual use in the spacecraft.

It became apparent that there were insufficient lithium hydroxide cartridges in the lunar module to support the abort mission, even with allowable carbon dioxide levels extended to a partial pressure of 15 mm Hg. With ground instructions, a system was constructed which attached a command module lithium hydroxide cartridge to each of two lunar module suit hoses. The Commander's remaining hose was placed in the tunnel area to provide fresh oxygen to the command module, while the Lunar Module Pilot's remaining hose was positioned in the lunar module environmental control area. At a later time, a second cartridge was added in series to the cartridges initially installed, as shown in figure 6.7-1. In each case, the drop in carbon dioxide levels reported by the ground showed satisfactory operation of this improvised carbon dioxide removal system.

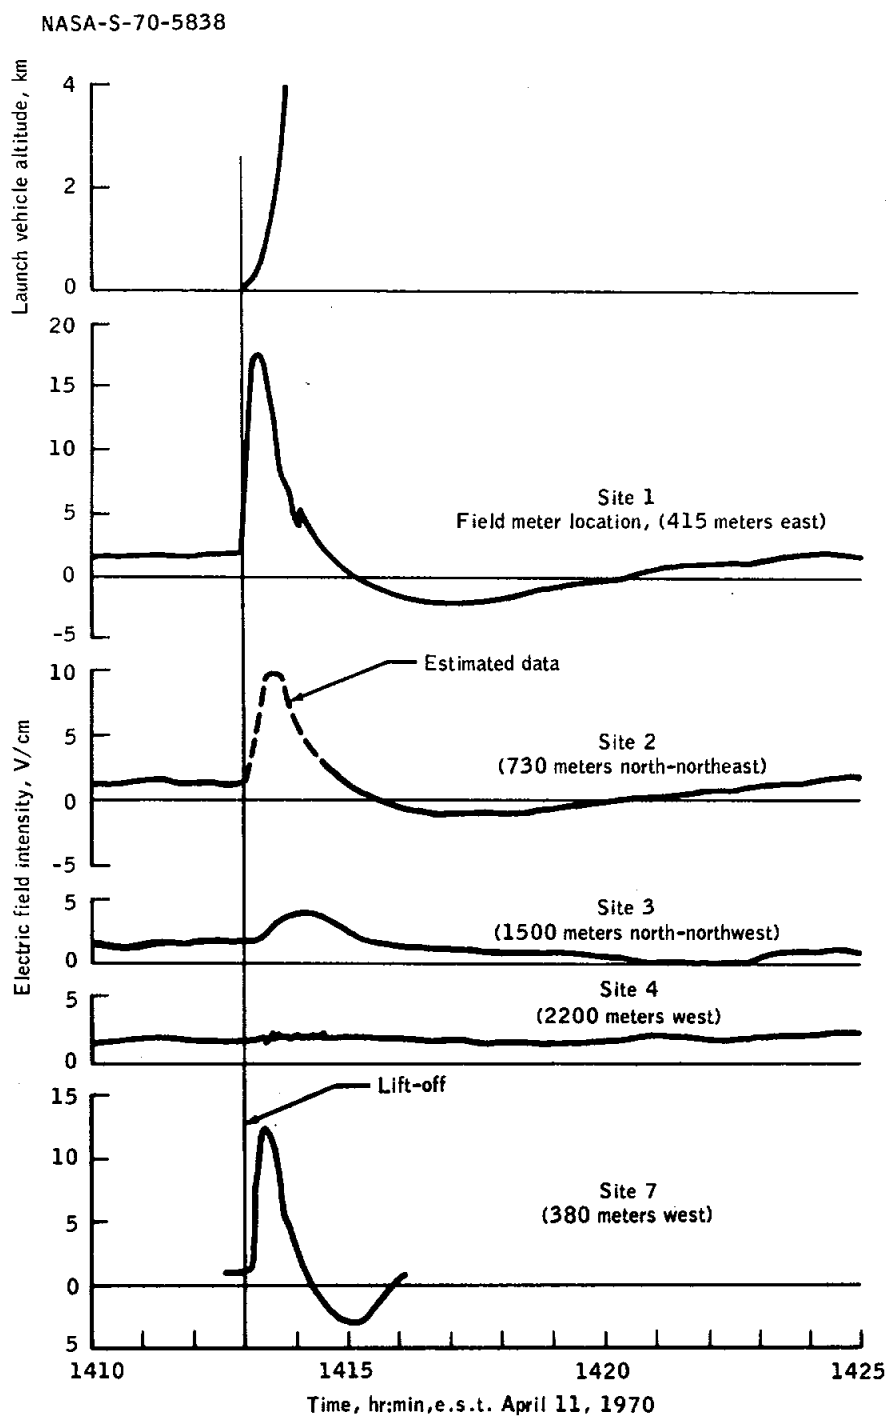
Figure 11.1-3.- Electrical discharge data for the Apollo 13 launch.

At site 6, the record was similar to that for site 7 with an initial positive excursion followed by a slower negative change. At this station, however, there were large fluctuations superimposed on the record, as shown in figure 11.1-3(b). These fluctuations could have been caused by

gravel and dust stirred up by the exhaust of the launch vehicle engine. After launch, a quantity of such debris was found near the surface of the field meter and its surrounding area. After the oscillations had subsided at T plus 40 seconds, there was a large negative field of approximately minus 3000 volts/meter which probably resulted from the exhaust and steam clouds that tended to remain over site 6.

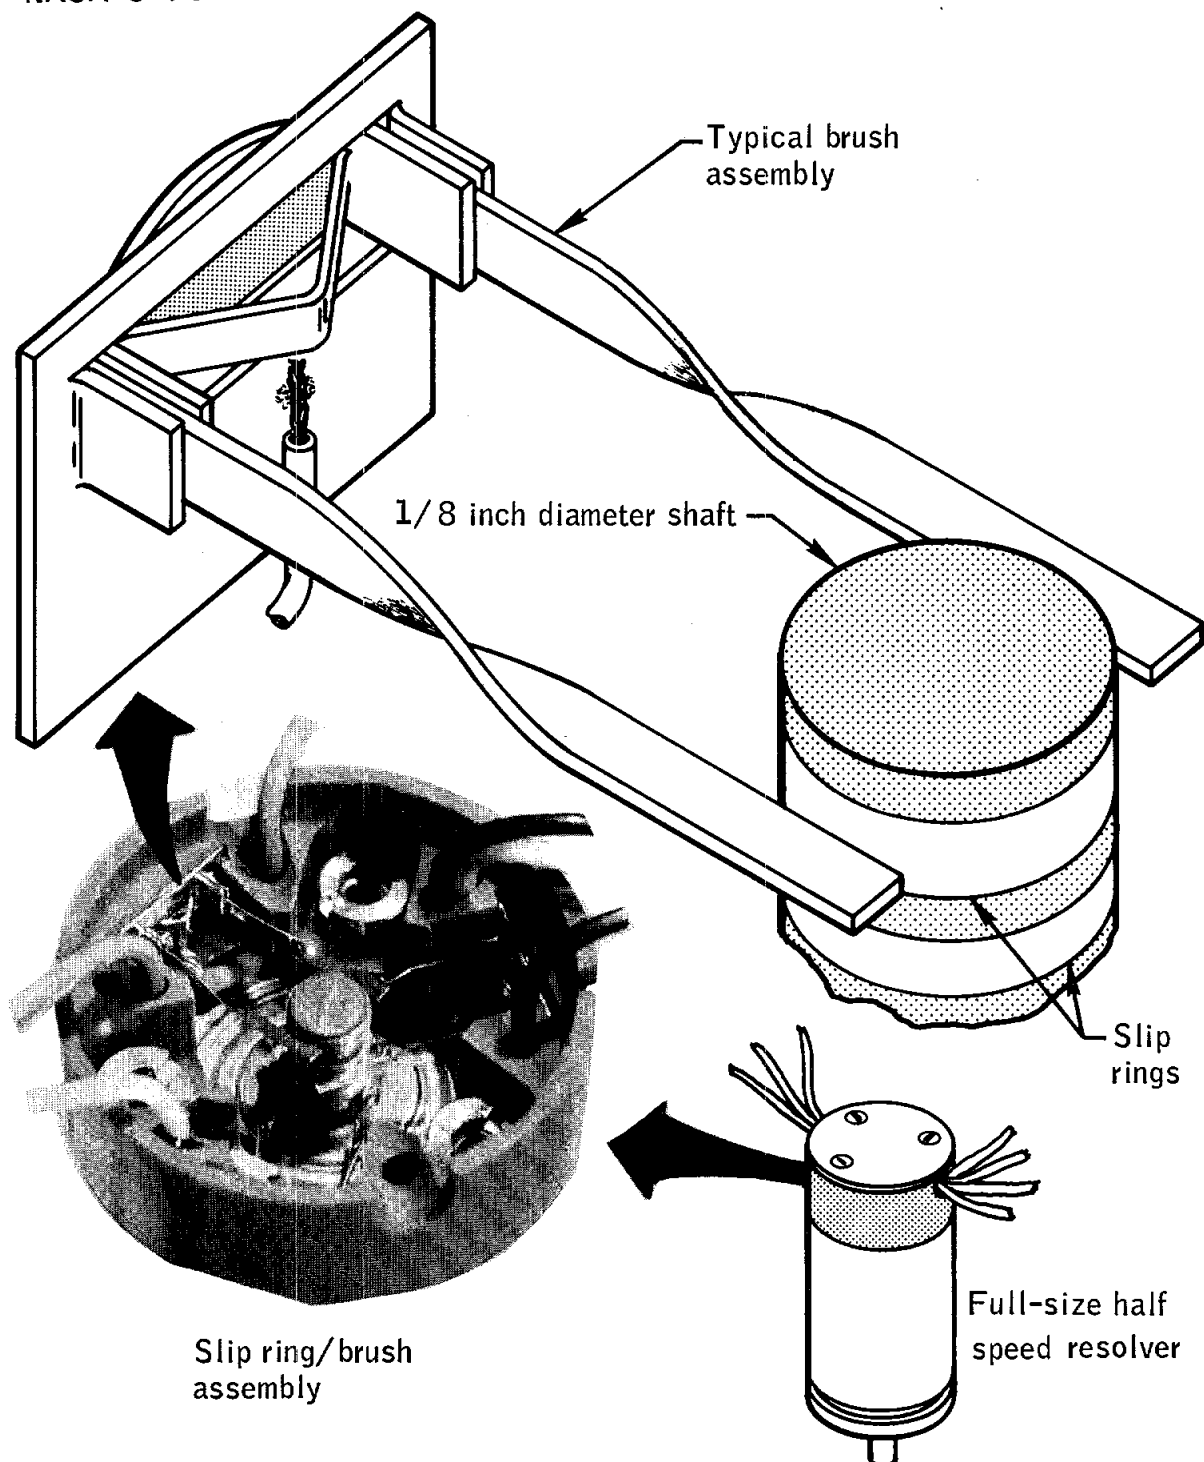
Figure 14-3.- Details of half speed resolver.

The most likely candidate is the half-speed resolver, which is used only for the shaft axis and only to provide an unambiguous zero reference. The reference voltage is applied to the rotor through slip rings (fig. 14-3), connected as shown in figure 14-4. If any resistance is present in the common ground path through the slip ring, a portion of the reference voltage will appear across the quadrature winding and induce a finite output (different than zero). Zero output is equivalent to zero degrees in shaft rotation.

Some evidence of susceptibility to vacuum was exhibited in this class of resolvers during qualification testing when variations of approximately 5 ohms were observed in the slip ring resistance during thermal

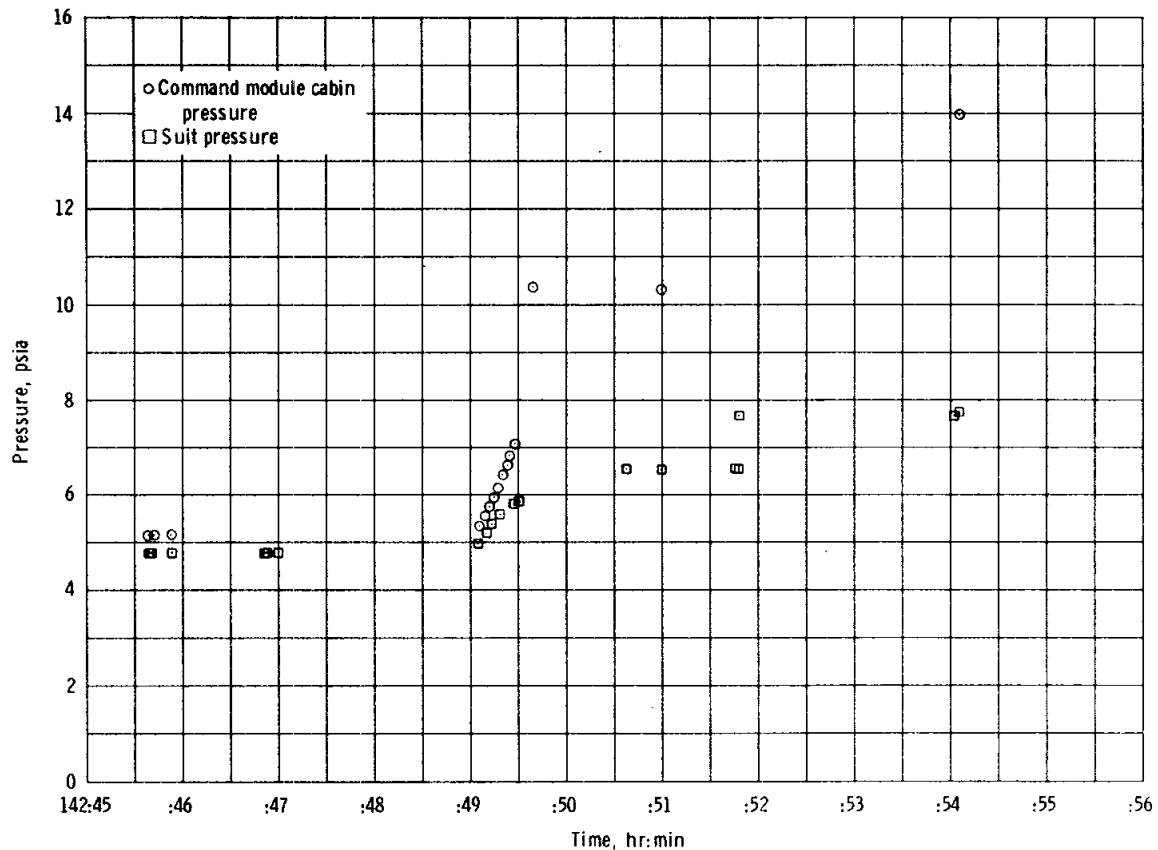
Figure 14-12.- Concluded.

During launch the suit pressure transducer reading remained consistent with cabin pressure until 00:02:45, then suddenly dropped from 6.7 to 5.7 psia coincidentally with S-II engine ignition (fig. 14-12). The difference between the two measurements decreased to only 0.2 by 1-1/2 hours, when the cabin reached its nominal regulated pressure of 5.0 psia. For this shirtsleeve mode, the suit and cabin pressure readings should be nearly equal. During normal variations in the command module cabin pressure, the suit pressure measurement responded sluggishly and indicated as much as 1 psi low. Subsequently, the measurement output decayed and remained in the 4.1 to 4.3 psia range for a cabin pressure of 5.0 psia until system deactivation at about 59 hours (fig. 14-12).

During periods when the lunar module and the command module cabins were interconnected, the lunar module and command module cabin pressure readings were approximately equal, verifying the operation of the command module cabin pressure transducers.

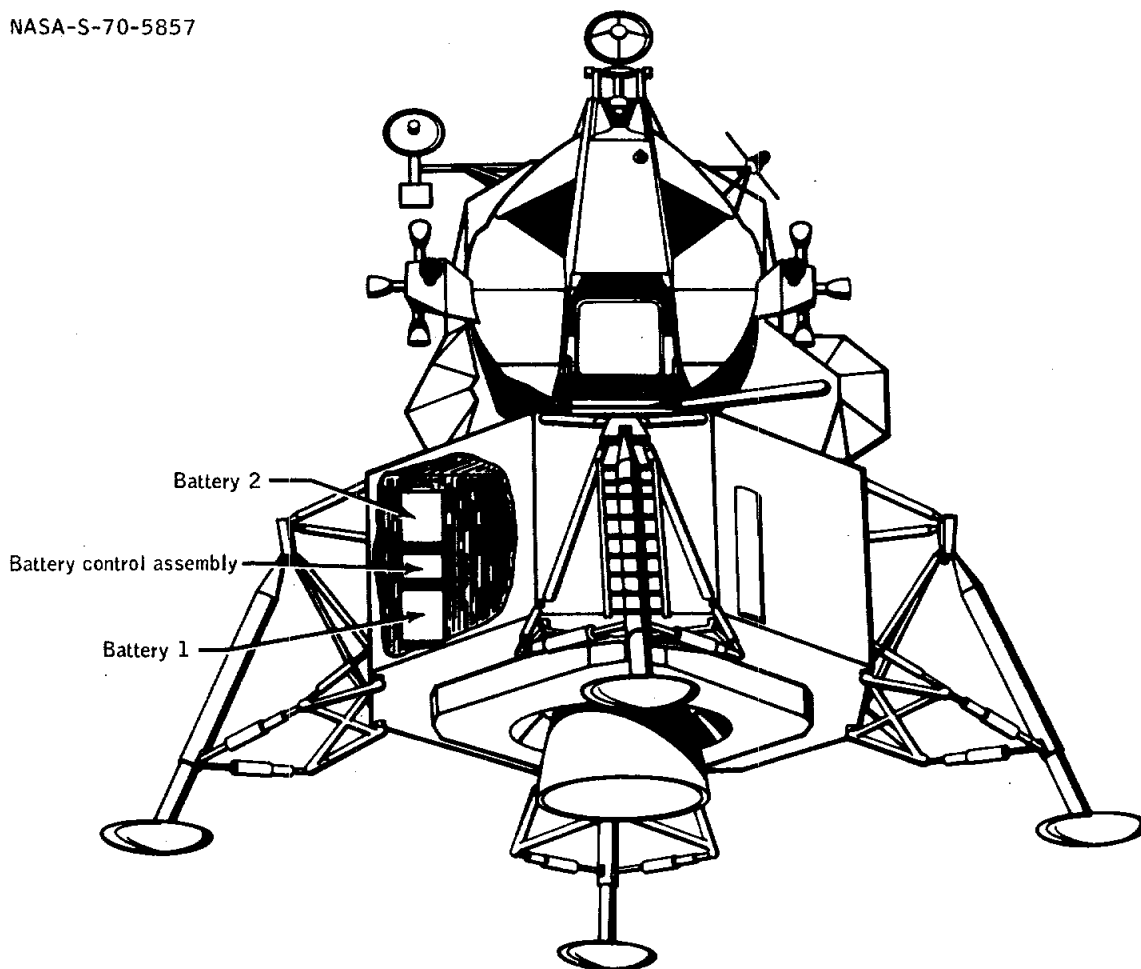
Figure 14-15.- Descent stage battery location.

At 97 hours 14 minutes, the crew reported a thumping noise and snowflakes venting from quadrant 4 of the lunar module descent stage (fig. 14-15). All four descent batteries experienced current transients at 97:13:53 for about 2 seconds, with corresponding drops in dc bus voltage (fig. 14-16). Also, the water glycol pressure differential for the heat transport system decreased momentarily, indicating that the glycol pump momentarily slowed down.

The thumping noise occurred at about the same time as the current spikes. The current spikes show that a momentary short circuit existed in the Lunar-Module-Pilot side of the dc electrical system, which includes descent batteries 1 and 2 (fig. 14-16). The current surge was not of sufficient duration either to open the balance-load cross-tie circuit breakers, to display a reverse current indication, or to trip a battery-off relay as a result of an overcurrent condition.
