APOLLO 8 MISSION REPORT

MANNED SPACECRAFT CENTER  
HOUSTON, TEXAS  
FEBRUARY 1969

Mission Evaluation Team

George M. Low  
Manager, Apollo Spacecraft Program

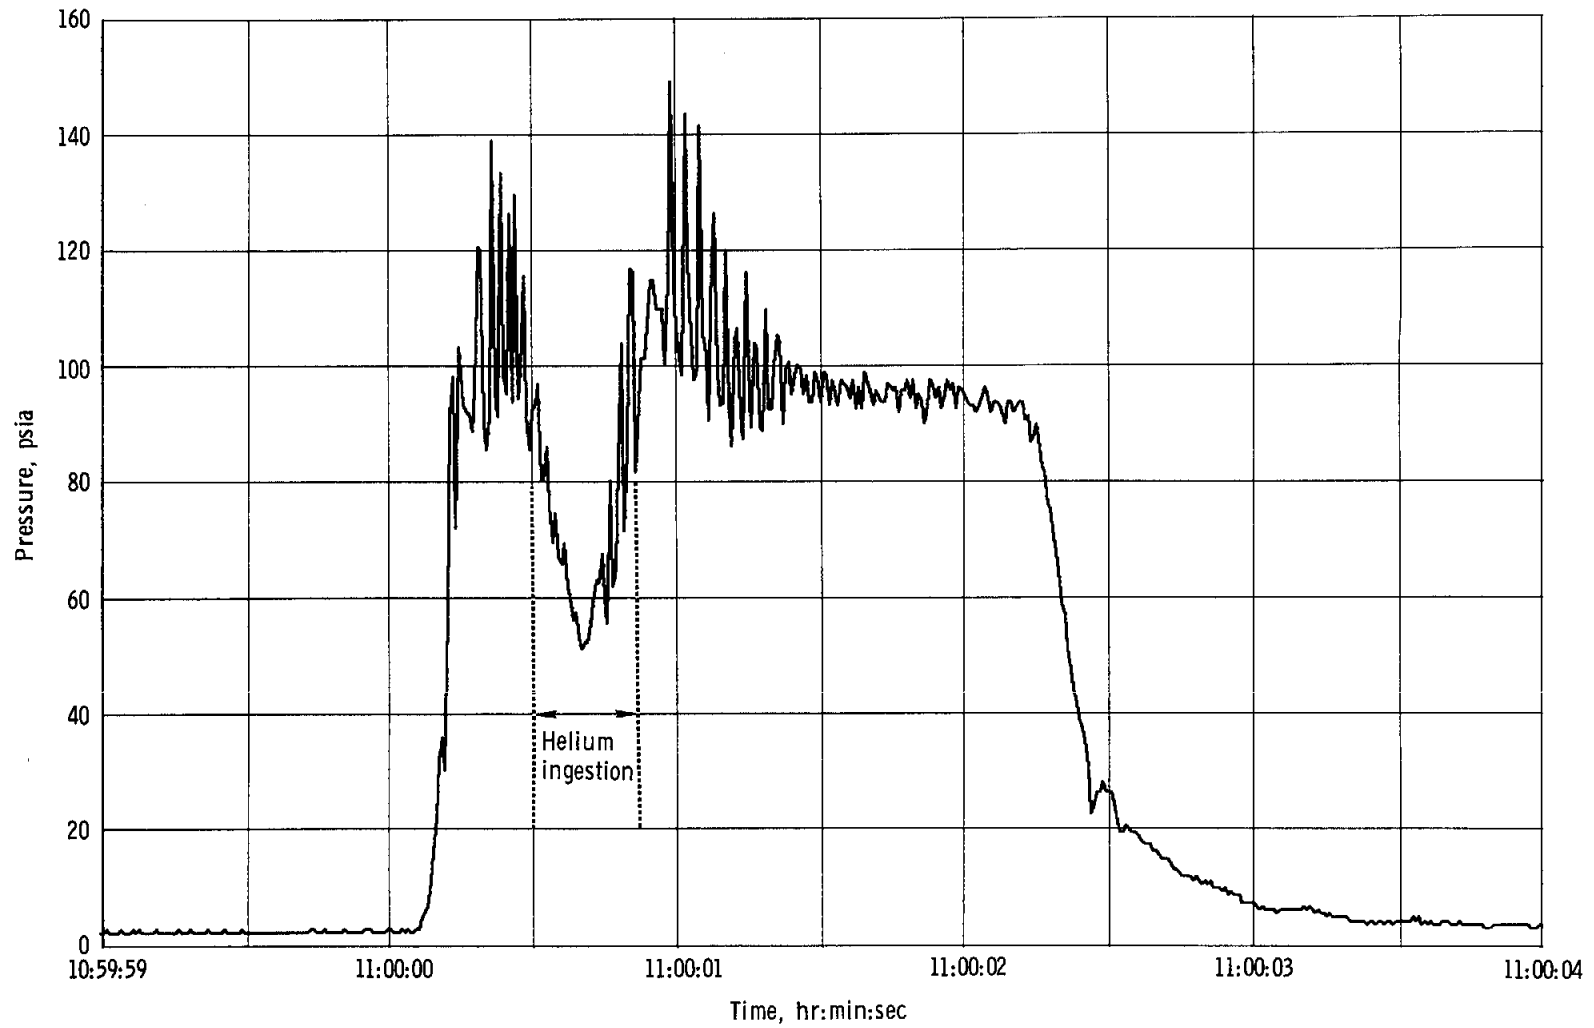
Figure 6.11-1. - Chamber pressure during first service propulsion maneuver.

A momentary drop in chamber pressure (fig. 6.11-1) was observed at the start of the first maneuver; this drop is attributed to the presence of a helium bubble in the oxidizer feed line. The trapped helium resulted from an inadequate engine-oxidizer bleed during preflight servicing. Comparable chamber pressure traces were obtained during a spacecraft ground test when the bleed procedure was also improperly conducted and during the AS-202 mission, during which the second service propulsion maneuver also exhibited helium ingestion. Chamber pressure characteristics were normal for the remaining three maneuvers. Bleed procedures have been changed in future spacecraft to preclude recurrence of trapped helium in the lines.

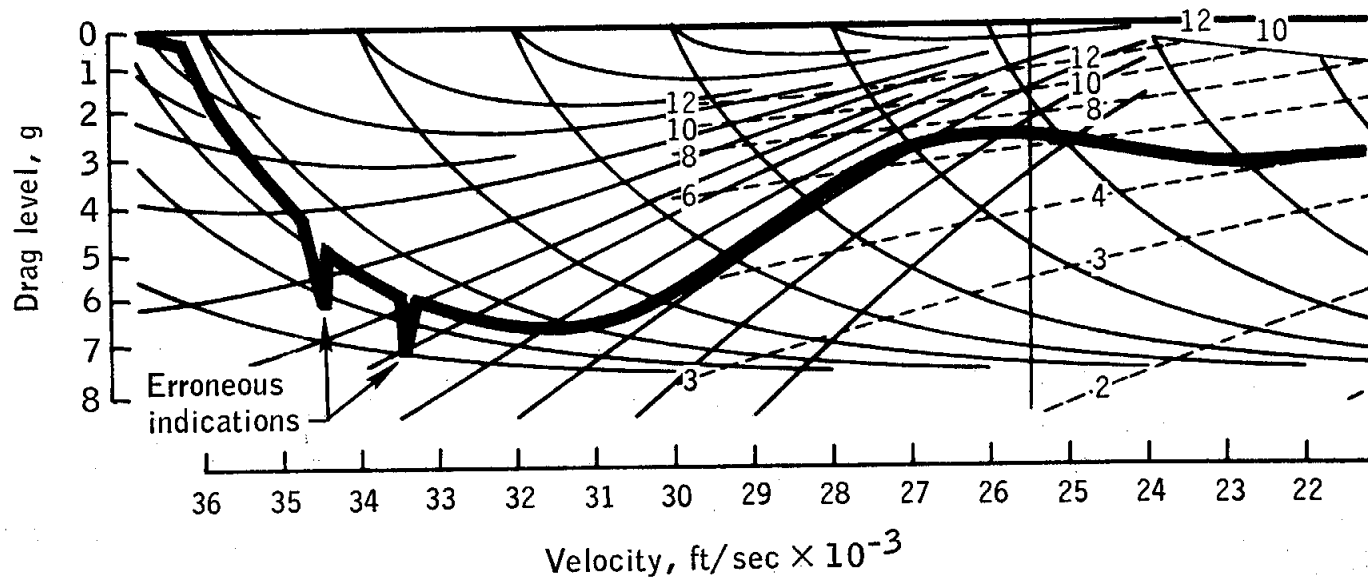
Figure 12-1.- Entry monitor system scroll.

1. During the spacecraft/S-IVB separation sequence, the delta V counter jumped 100 ft/sec.
2. For the third midcourse correction, a delta V of 5 ft/sec was entered into the entry monitor system. The system counted to zero at delta V cutoff; however, it continued to count after the maneuver and was finally turned off by the crew.
3. At times when the mode switch was rapidly switched from "stand-by" to "automatic," the delta V counter jumped 19 to 20 ft/sec.
4. For the initial entry phase, the g/velocity trace on the entry scroll showed two short, incorrect g transients (fig. 12-1). Operation of the scroll assembly was normal in all other respects.

The entry monitor system was removed from the spacecraft, and no abnormal indications were observed in functional tests. However, during tilt-table tests, abnormal accelerometer outputs were observed when random 0.25g pulses were produced at approximately 0.8g. Detailed testing and inspection of the accelerometer disclosed a bubble in the damping fluid. The bubble may explain the behavior of the g trace during entry and the random pulses during the tilt-table test. The bubble may also be associated with the problem after the midcourse correction, in that it has been demonstrated that the time for the accelerometer to drive to null greatly increases when a bubble is present.

The accelerometer case contained 1 cubic centimeter less fluid than when it was originally filled. Indications near the fill port are that damping fluid had leaked around the O-ring seal. The seal has been changed from a screw to a plug type for units to be flown on spacecraft 106 and subsequent.

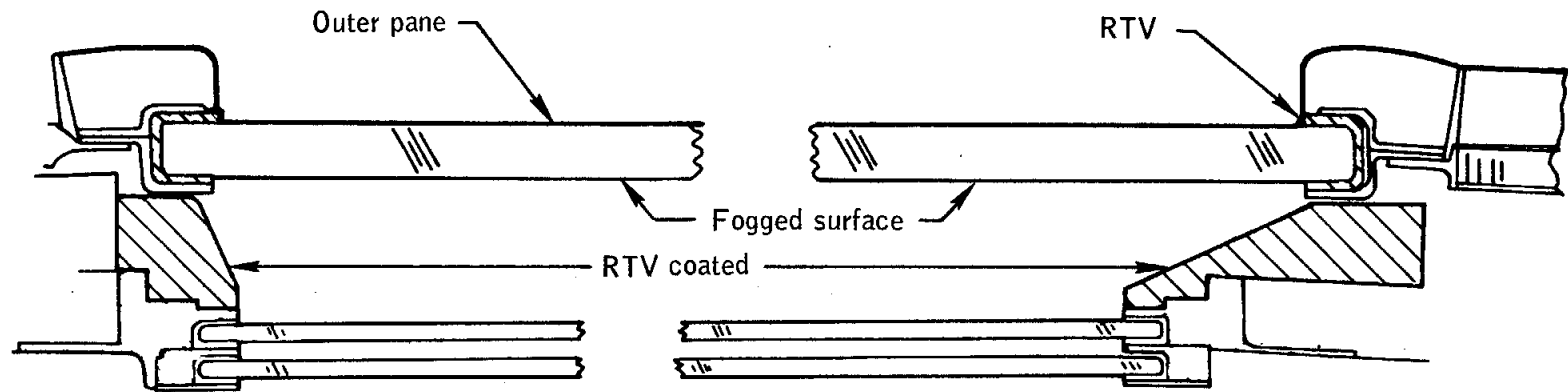
Figure 12-2.-Side window cross section (also typical for hatch window).

Visibility through the hatch window was degraded to the point that the window was useless for visual observation and photography after approximately 6 hours. The two side windows (1 and 5) were fogged but to a lesser degree. The two rendezvous windows (2 and 4) remained usable throughout the flight. These conditions were consistent with what was expected as a result of the Apollo 7 window fogging analysis, which showed the primary cause to be outgassing of silicone oils from the RTV sealing material.

Figure 12-2 shows a cross section of the side windows, including the typical installation of the three windows and the location of the modification. The modification consists of a new RTV curing process to greatly reduce the residual oils.

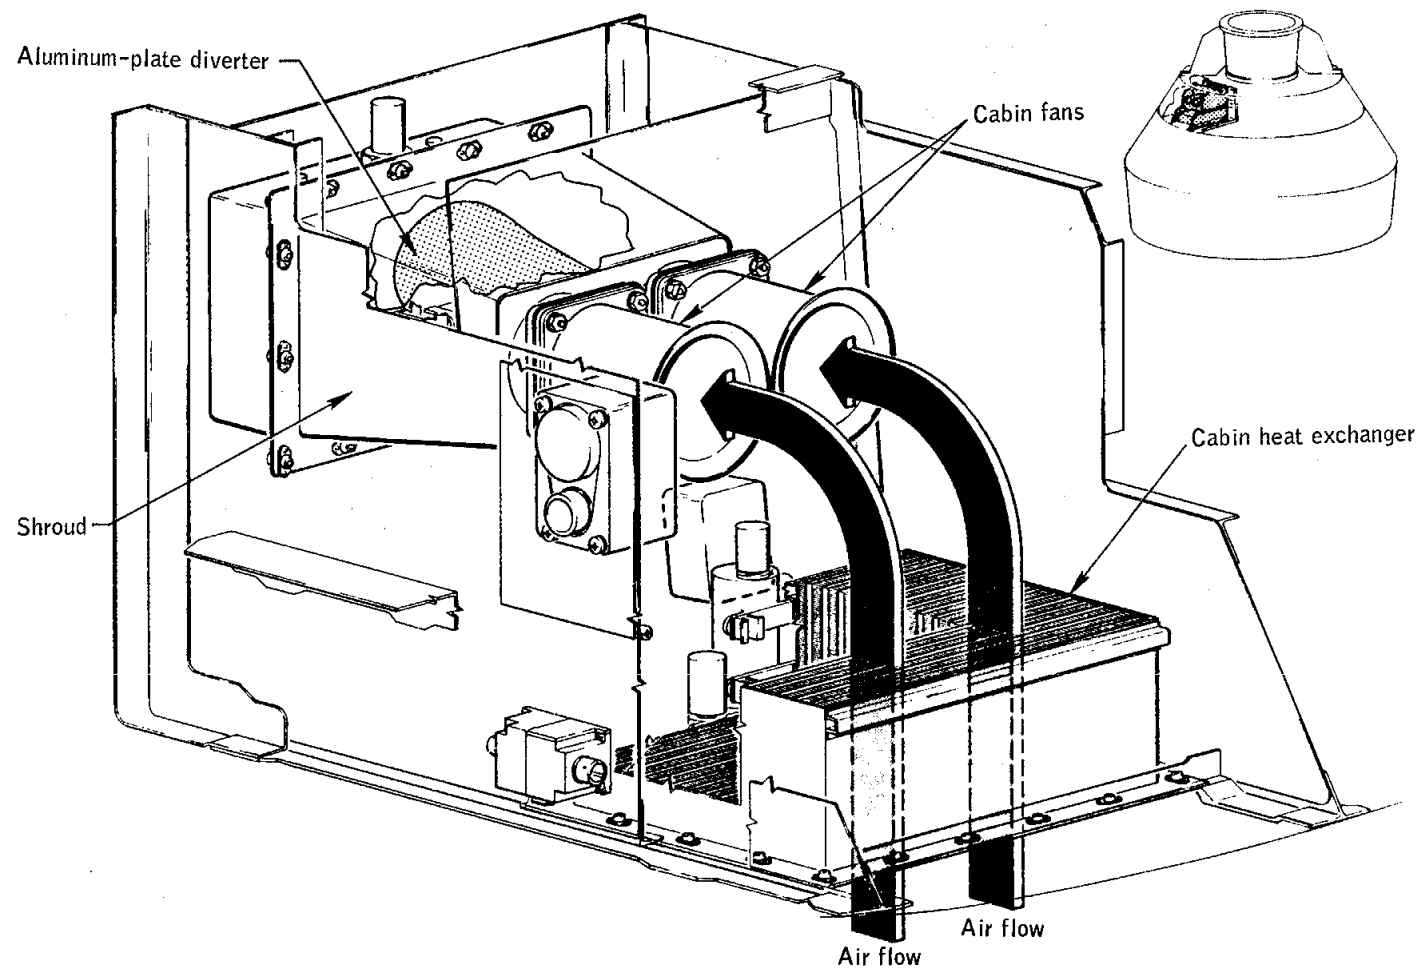
Figure 12-3.- Cabin fan installation.

During the sixth day of the mission, the cabin fans (fig. 12-3) were momentarily turned on, and the crew reported that both were noisy.

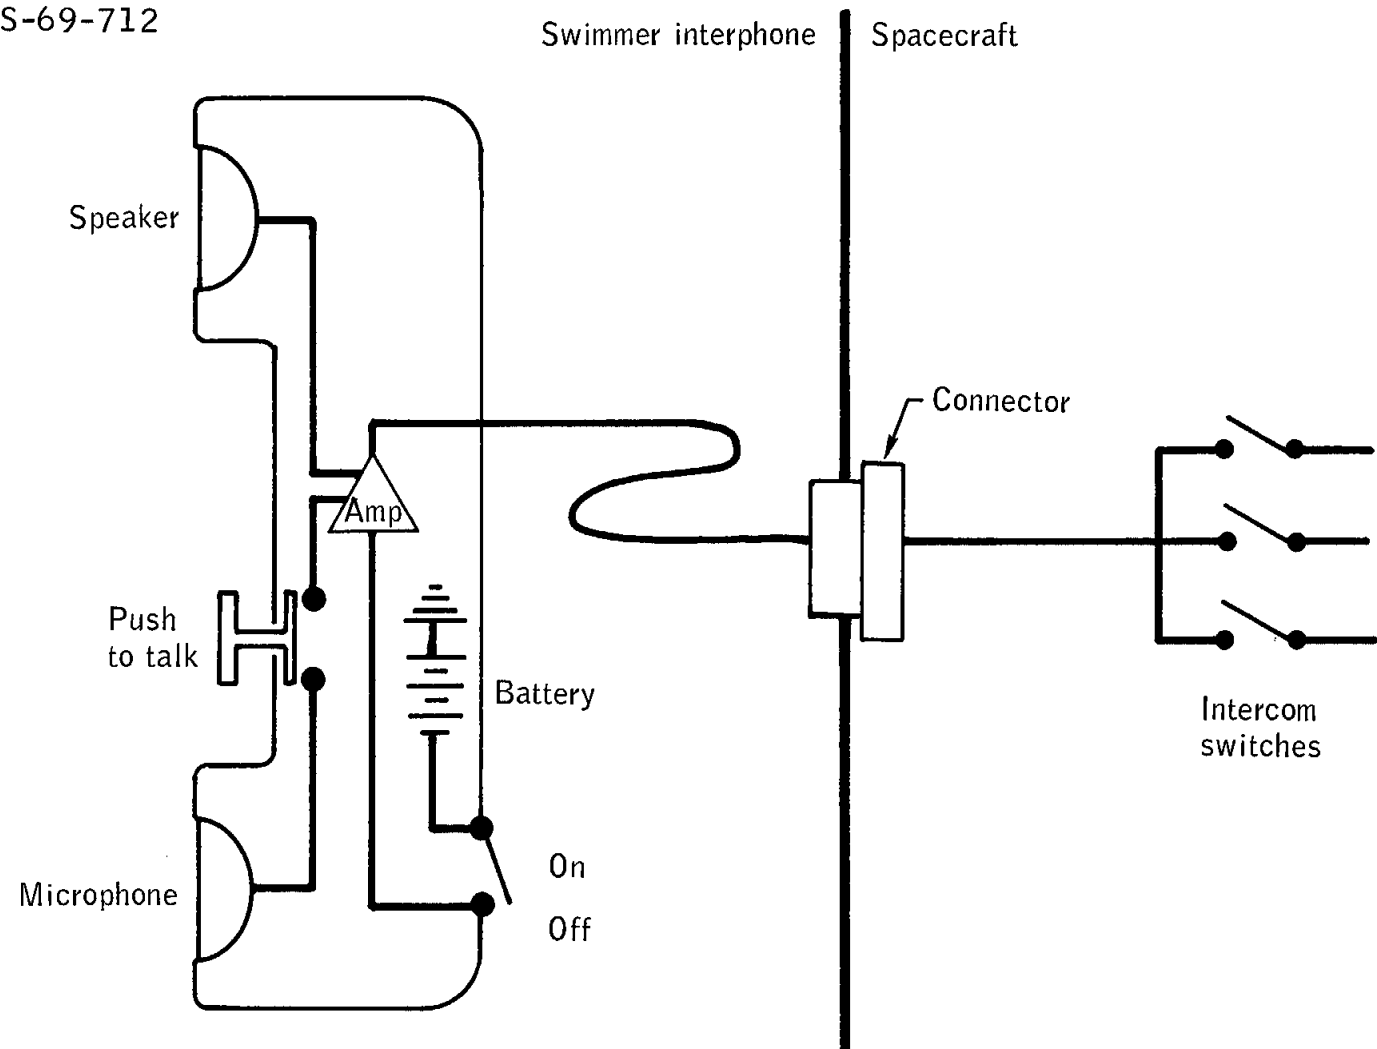
Figure 12-6.- Swimmer interphone.

During recovery operations, the swimmers were unable to communicate with the crew via the intercommunications system. The crew reported that the spacecraft intercom switches were in the proper position. As shown in figure 12-6, the swimmer interphone, which plugs into the spacecraft, has a push-to-talk switch and an ON-OFF switch.

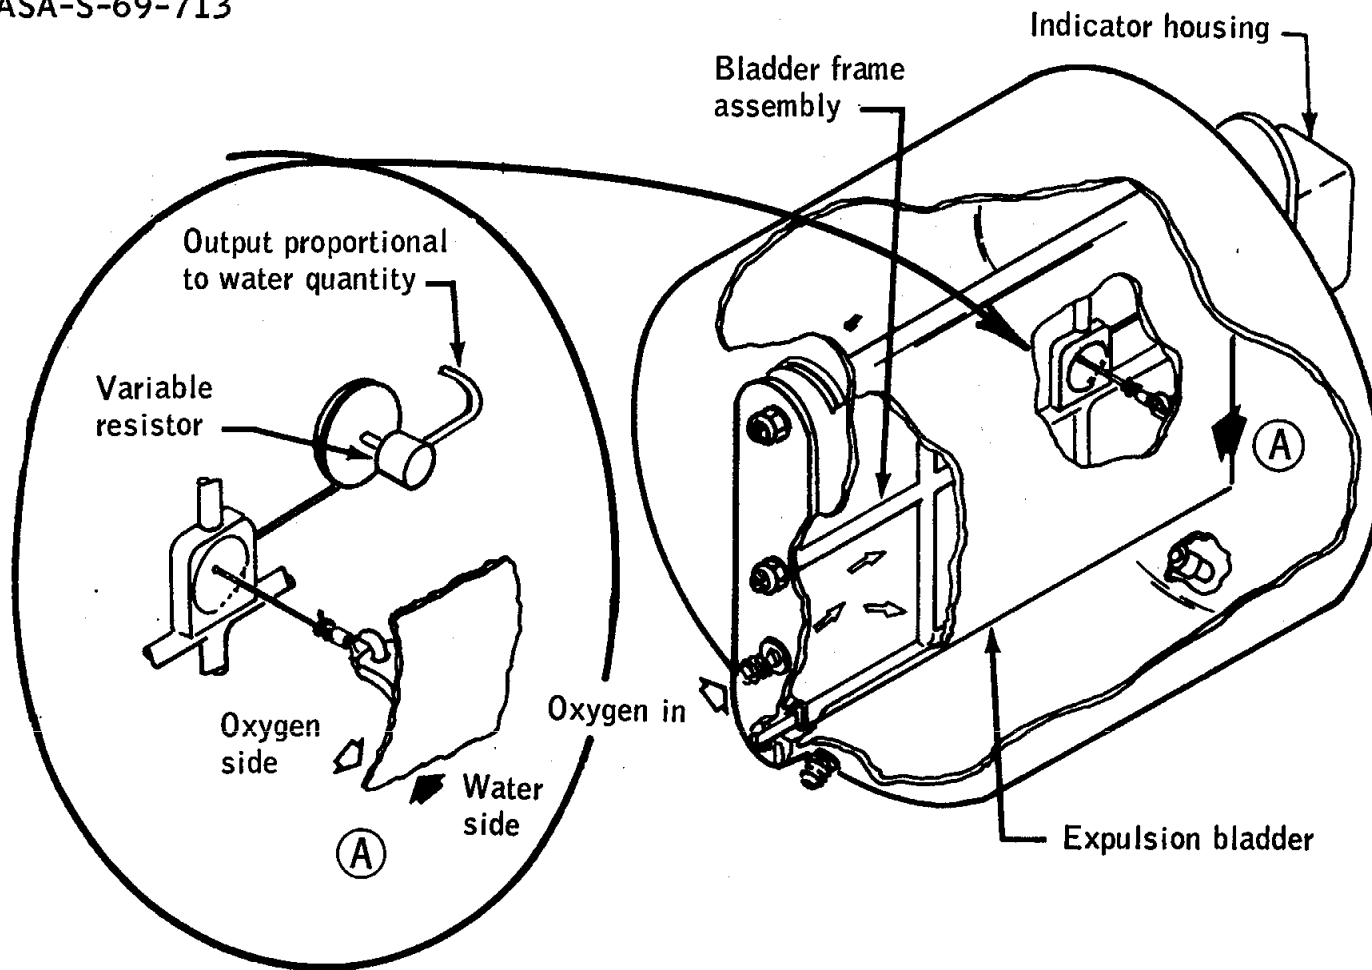
Examination of the disassembled unit (fig. 12-7) revealed corrosion in the indicator housing, on the variable resistor, and on the actuator pulley, indicating moisture had been present in the oxygen side of the tank pressurization system. The actuator line was broken, probably as a result of postflight calibration with the pulley shaft frozen from corrosion. Analysis of the residue in the area indicated that the contaminant was urine and possibly water from the waste water tank. The contamination could have come through the oxygen bleed filter and orifice (fig. 12-8) into the indicator housing and bladder.

Figure 12-7.- Potable water tank.

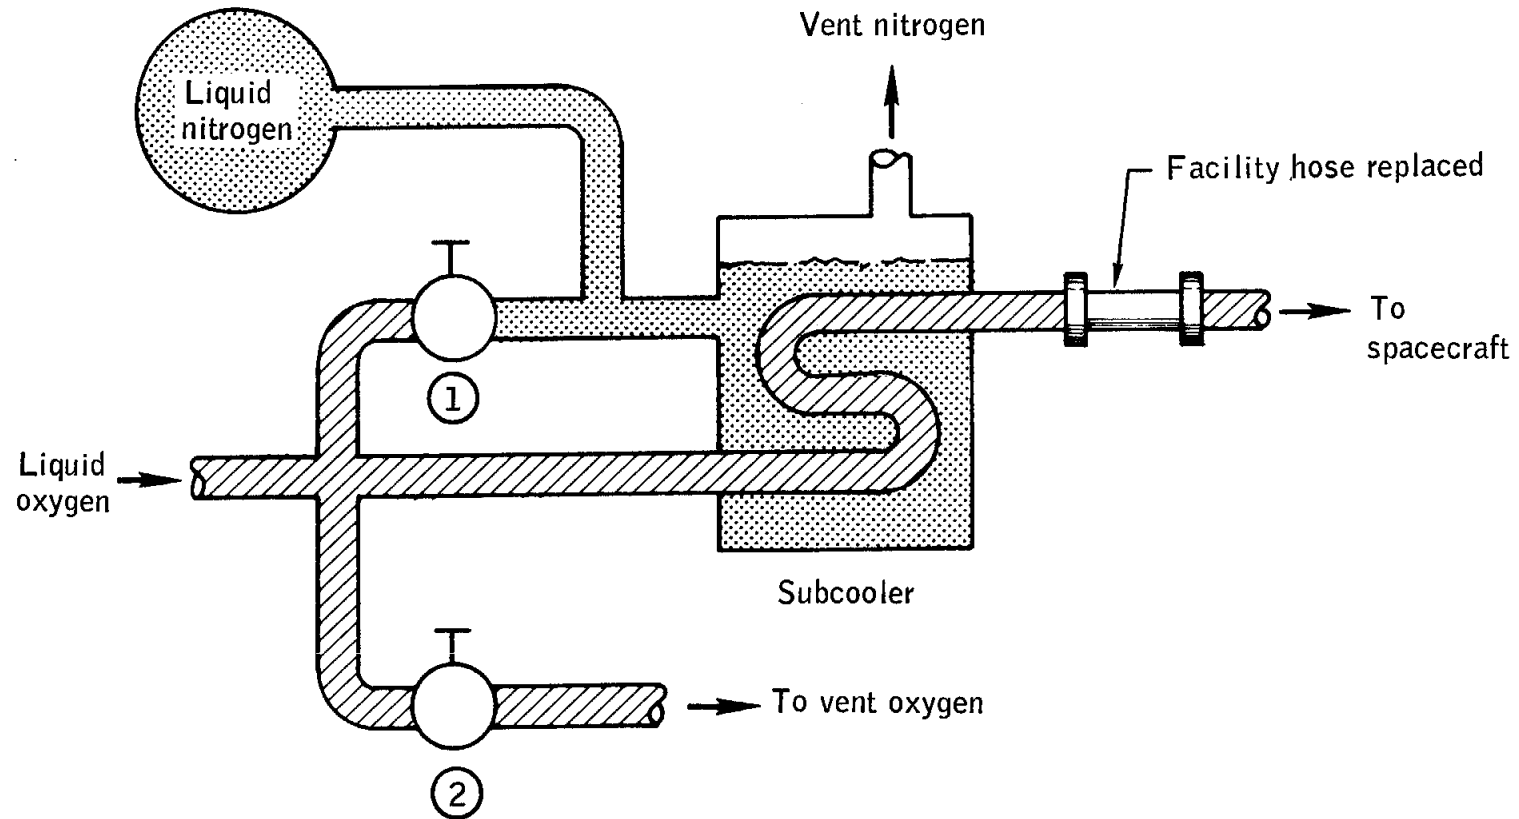
Figure 12-9.- Simplified schematic of cryogenic oxygen servicing unit.

Figure 12-9 shows only the basic system elements associated with the problem.

During normal servicing operation, liquid oxygen flows through a subcooler, which is chilled by liquid nitrogen. Valves 1 and 2 are closed during this operation.

While servicing liquid oxygen, a leak developed in a facility liquid oxygen line, causing a safety shutdown. To preclude overpressurization because of stagnant liquid oxygen, the system was vented using the normal shutdown procedure. This procedure was incorrect in one area, which called for opening valve 1 instead of valve 2. This error allowed liquid nitrogen to flow through valve 1 into the liquid oxygen supply line. Procedures have been corrected and verified by test. This anomaly is closed.
