# **RESULTS OF THE SECOND U.S. MANNED SUBORBITAL SPACE FLIGHT JULY 21, 1961**

**MANNED SPACECRAFT CENTER  
NATIONAL AERONAUTICS  
AND SPACE ADMINISTRATION**

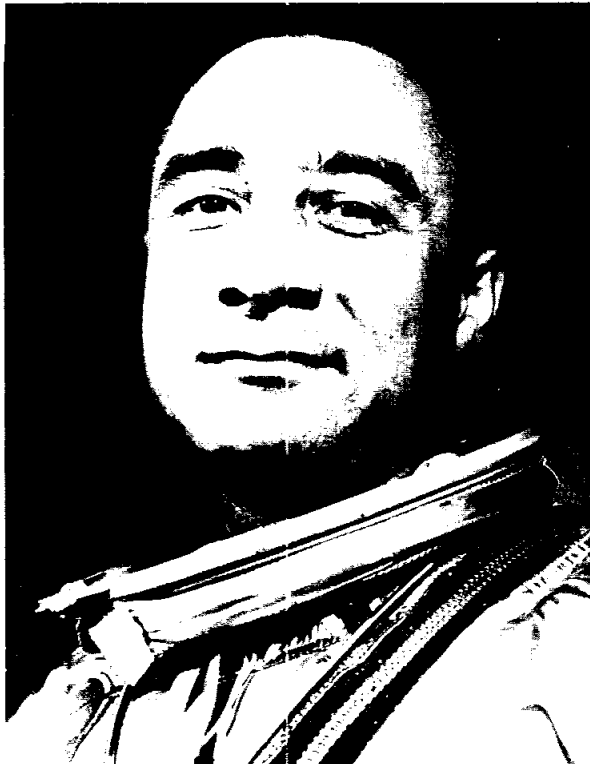
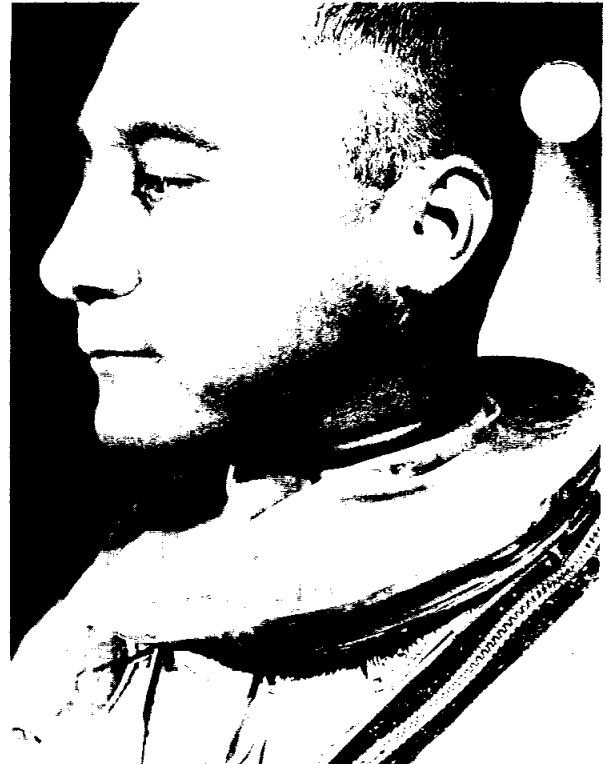
FIGURE 7-6. Neck dam.

(a) Normal stored position.

(b) Unrolled position.
